# 3.6 Ecosystems and Access to Nature

## 3.6 Ecosystems and Access to Nature

### 3.6.1 Habitats and Species

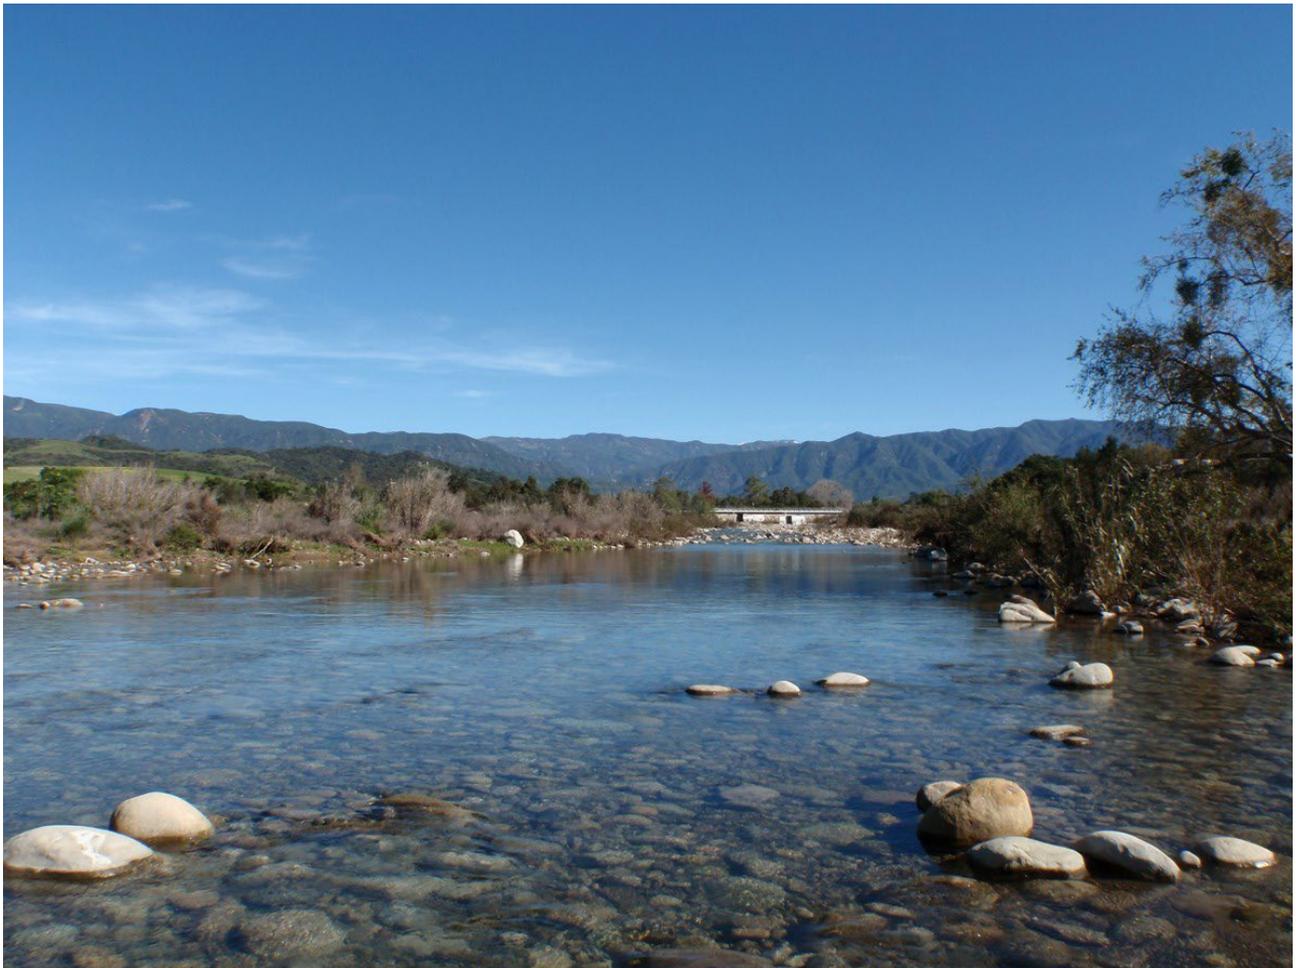
**Ventura River's Dry Reach, Intermittent Riverine Wetland.** The watershed's riverine wetlands are quite variable, ranging from intermittent stream/river reaches (sections) that usually flow only in the winter and spring, such as the “dry reach” (pictured above in its wet state), to perennial reaches that flow year-round.

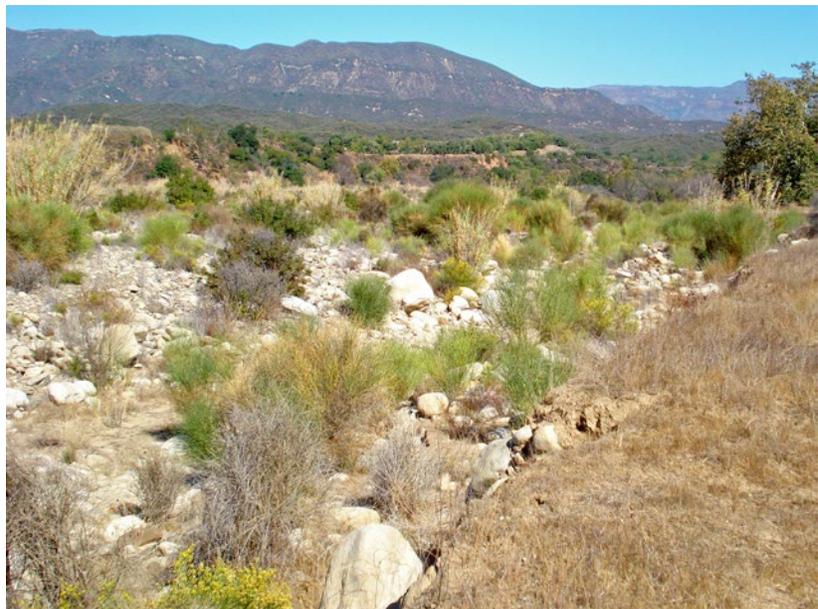
**Alluvial Scrub, Ventura River Bottom.** This habitat type occurs primarily on variously elevated alluvial benches that are protected from regular flooding by topography, but may be subject to some infrequent flooding or inundation. Upland plant species may also be found growing periodically on alluvial scrub terraces. Ground cover between shrubs is open with variable cover of native and non-native annuals and herbaceous perennials. It is likely that these areas were washed over by high flows sometime in the past several decades.

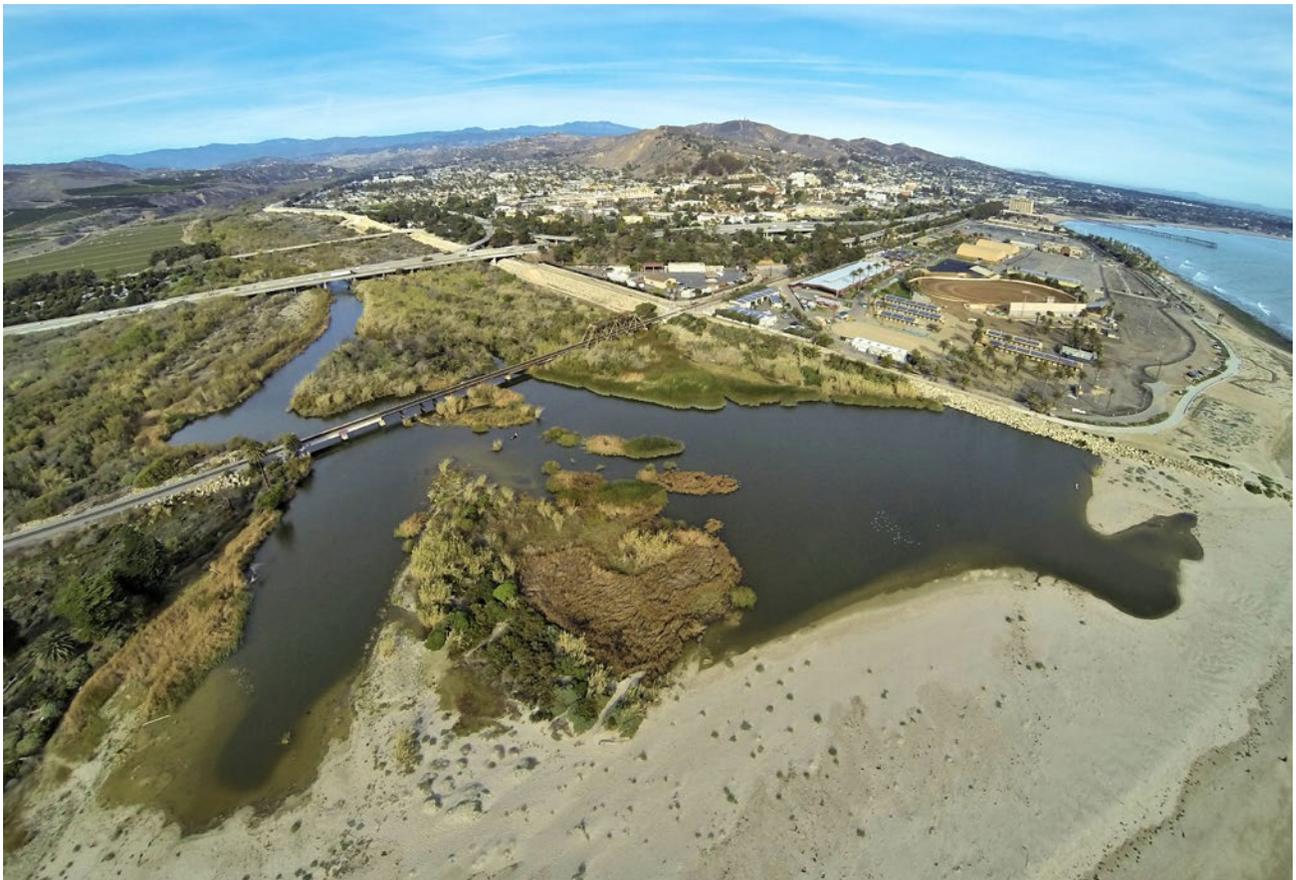
**Ventura River Estuary, February 2014.** The estuary extends from the ocean to the area between the Highway 101 bridge and the Main Street bridge upstream (Ferren et al. 1990). It is a lagoon type of estuary, separated from the ocean by a sandbar that generally remains closed off from the ocean. Water periodically breaches the sandbar. The second mouth of the estuary, not shown in this photo, is further west.

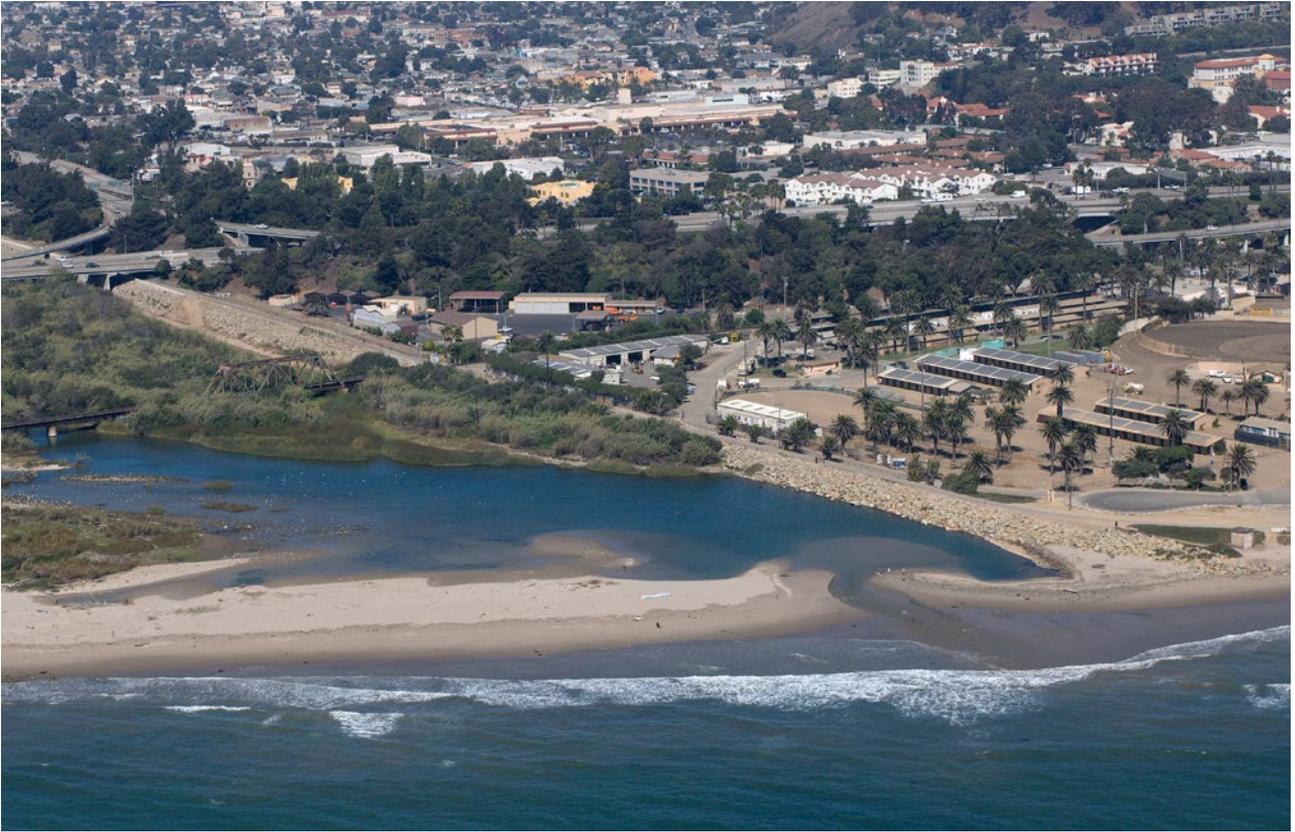
**Breached Sandbar, Ventura River Estuary, September 2014.** The sandbar that impounds water at the mouth of the Ventura River opens and closes depending on the interactions between river flow and wave action. Winter storm flows often scour out the sandbar, allowing regular tidal flows into the estuary for a period of time. Occasionally the mouth opens during the summer (Ferren et al. 1995).

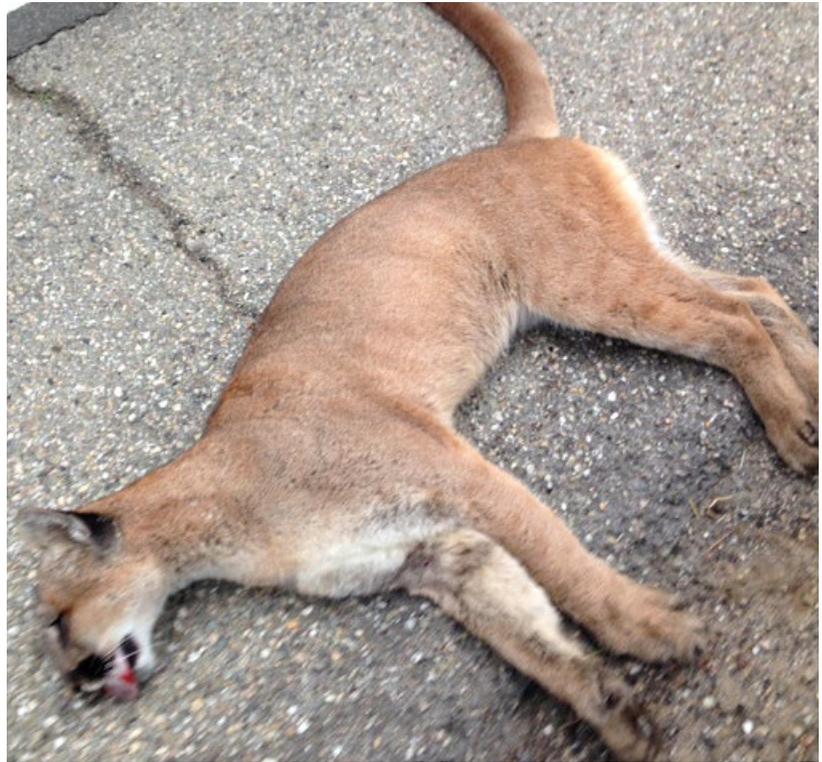
Animals killed by cars are regularly seen on Highway 33 near Foster Park.

Collected data on roadkill reveal locations in the watershed where highly travelled roads intersect with well-travelled wildlife movement corridors. One such location is on Highway 33, just south of Foster Park. Roadkill in this area is unfortunately fairly common. Roadkill is also common on Highway 150 east of Lake Casitas (Anderson 2014).

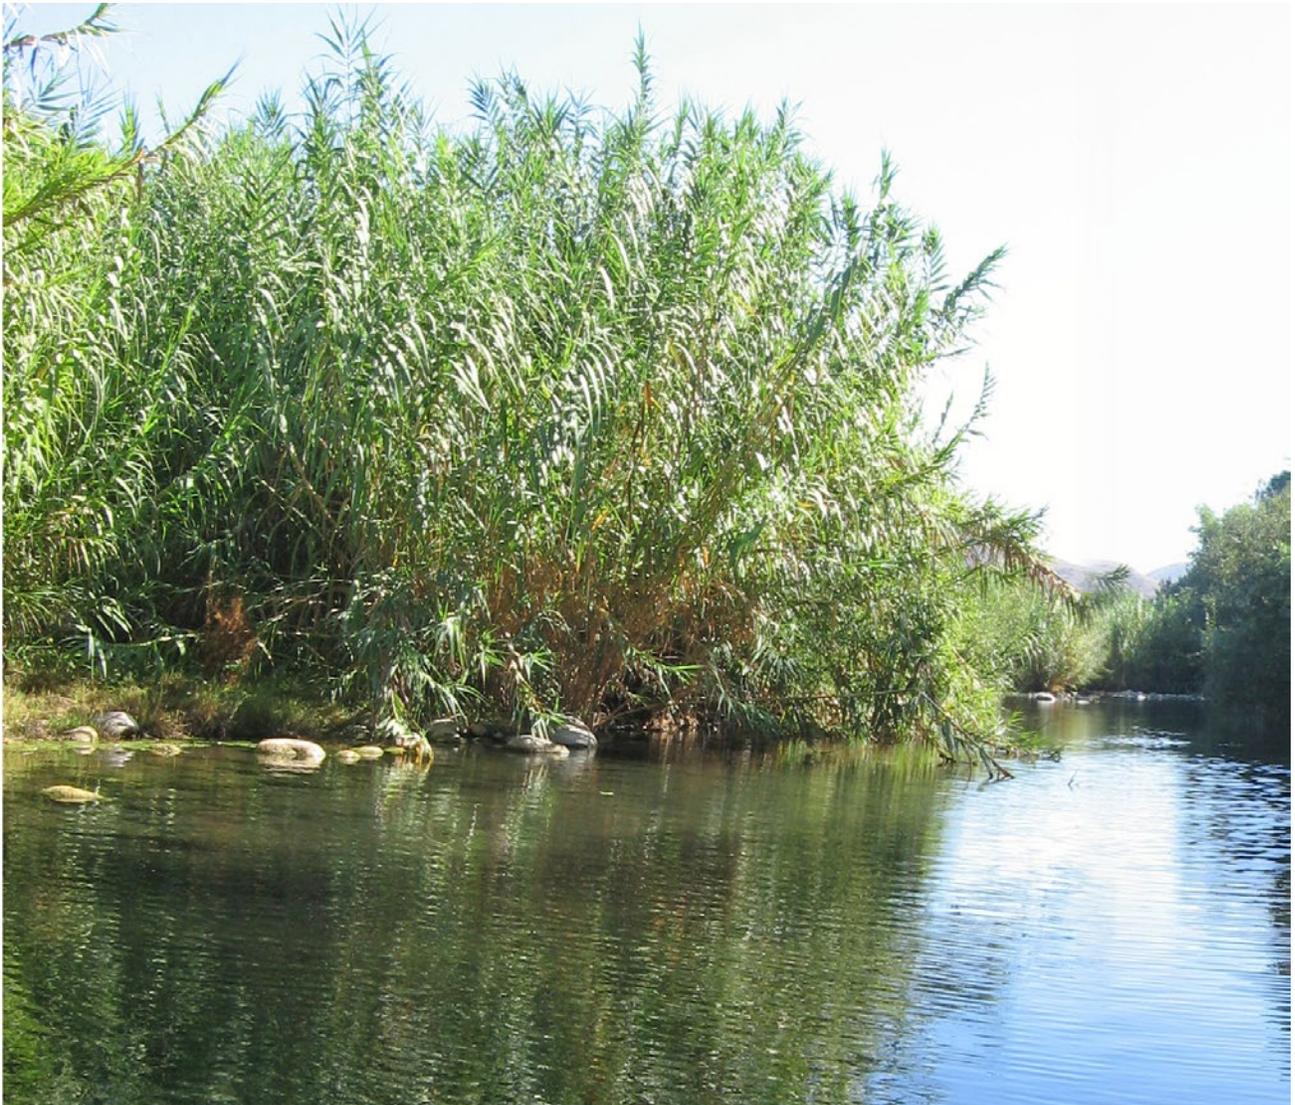
***Arundo donax* Below Foster Park, 2012**

*Arundo donax*, or giant reed, is by far the most problematic non-native invasive plant species problem in the watershed. It is a large bamboo-like grass that can reach heights of up to 30 feet and is among the fastest growing terrestrial plants in the world—it can grow up to four inches a day in its early growth stages (CIPC 2011). *Arundo* has become established in and is spreading throughout riparian ecosystems in California.

*Arundo* can grow into massive thickets of vegetation that cover many acres, forming monocultures that virtually eliminate all other plant species, along with the rich biodiversity, structural diversity, and wildlife habitat of riparian ecosystems. Avian and fish species are the most impacted by *Arundo* infestations, and amphibians are also highly impacted (CIPC 2011).

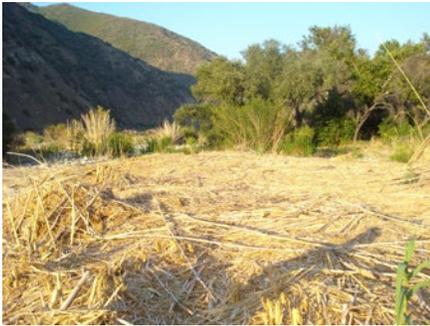
### Freshly Cut *Arundo*, Above Matilija Reservoir

*Arundo* has a thick, persistent underground stem system that looks like giant pieces of ginger. Like Bermuda grass, it grows by sending out underground vegetative shoots, called rhizomes, which readily take root and send up new stalks. *Arundo* spreads when pieces of cane or rhizome fragments break off, travel downstream, and take root in moist soil. The durability of these rhizomes is what makes eradication of *Arundo* so difficult. *Arundo* seeds appear to be almost always sterile in California (VCPD 2006).

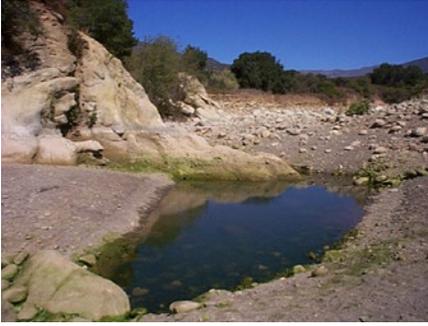
### A Drying Ventura River

Steelhead in the Ventura River watershed are dependent upon a pattern of water flows in the mainstem of the river and significant tributaries, sufficient in time and place to provide for migration, spawning, rearing, and holding habitats. Peak storm flows typically break the estuary sand bar and entice adult steelhead into the river network. Once in the river network, insufficient streamflow is a critical limiting factor to the spawning and rearing activities of steelhead. Steelhead prefer to spawn in perennial streams since one to three years is generally required for offspring to mature and reach the ocean. Intermittent reaches in the watershed often lack riparian vegetation,

Deficient streamflow is often a limiting factor for steelhead survival in upper San Antonio Creek and parts of its tributaries (Thacher, Reeves, and Senior Canyon Creeks), parts of Matilija Creek upstream of Matilija Dam, Coyote Creek downstream of Casitas Reservoir, Cañada Larga and Cañada del Diablo Creeks, and the upper mainstem Ventura River downstream of Robles Diversion Dam. Figure 3.6.2.1 illustrates the extreme variability in streamflow in the watershed.

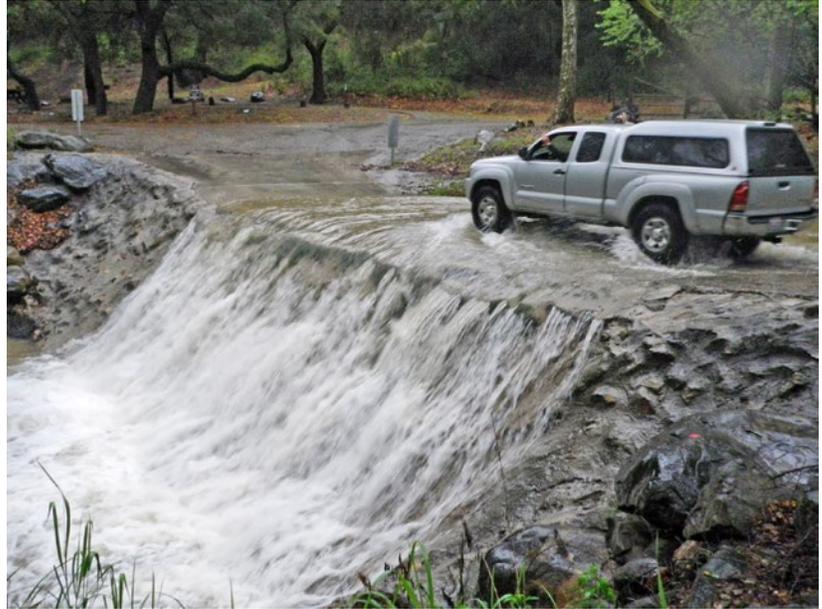
**Lower Wheeler Campground  
Crossing, Total Barrier, North Fork  
Matilija Creek**

Matilija Dam completely blocks access to most of Matilija Creek and its tributaries. Casitas Dam is a complete barrier, which blocks access to Coyote and Santa Ana Creeks. Other passage barriers and impediments, both natural and manmade, exist throughout the watershed, including on Matilija Creek and its tributaries, North Fork Matilija Creek, and upper San Antonio Creek and its tributaries.

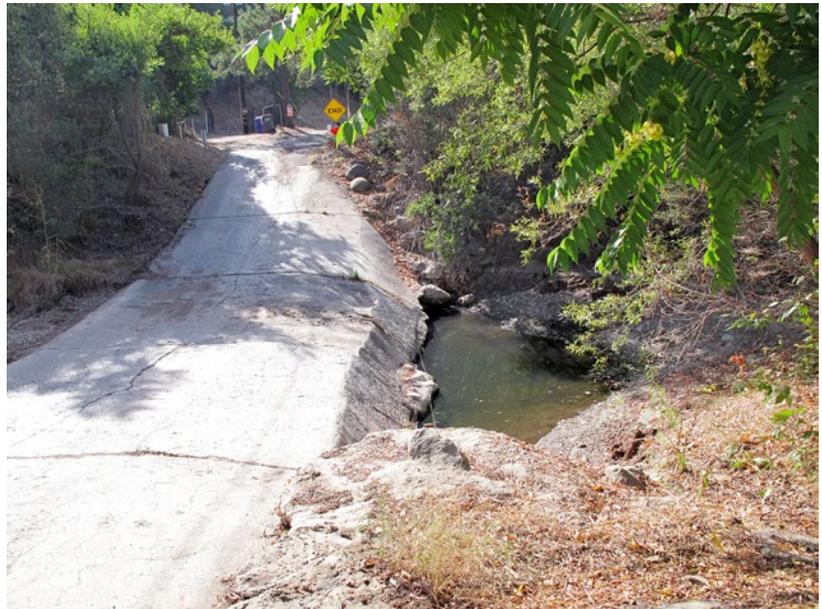
**Fraser Street Crossing, Partial Barrier,  
San Antonio Creek**

Fish passage barriers can be total barriers, partial barriers, or temporary barriers (e.g., from construction), and some barriers are only problematic at low flows. Barriers can also change over time, as storms blow out pipes or other obstructions that had acted as barriers. An on-the-ground assessment of current barriers and their priority for removal is needed in the watershed. Based on existing information, the barriers listed in Table 3.6.2.2.1 were identified by a Ventura River Watershed Council technical advisory committee as priorities for removal or mitigation in the watershed.

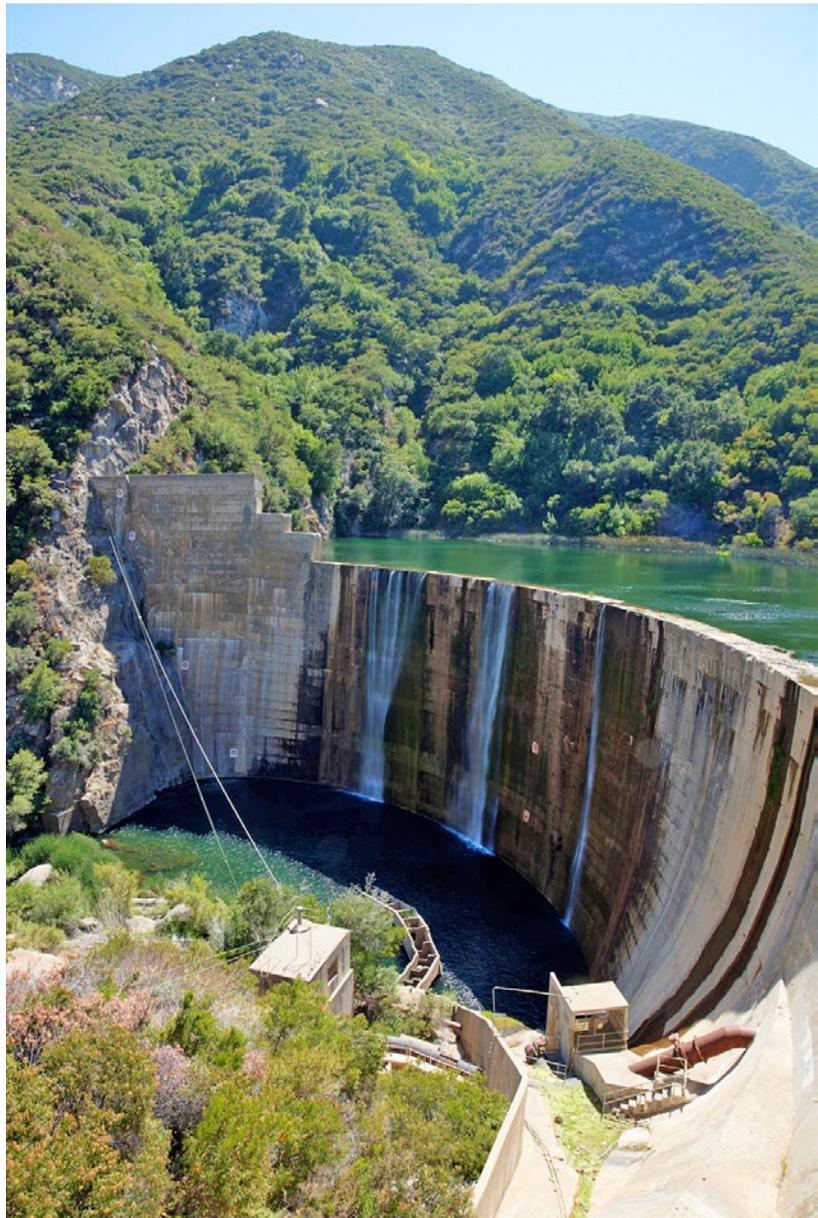
### Matilija Dam

Since its construction in 1947, Matilija Dam has blocked Ventura River adult steelhead access to roughly 13 miles of this watershed's most valuable steelhead spawning and rearing habitat (NMFS 2003). Dam removal would restore access to this vital habitat.

Matilija Dam is the watershed's most significant fish passage barrier because it blocks access to a large area of primary spawning and rearing habitat in the upper reaches of Matilija Creek and its tributaries (USACE 2004). The dam is located one-half mile above the Matilija Creek/North Fork Matilija Creek confluence, which is also the beginning of the Ventura River. Dam removal efforts started in the 1990s and continue today. Removing the dam is considered the highest priority issue for steelhead recovery in the watershed in the long term. The major effort to remove the dam, which also addresses sediment transport issues, is addressed in a separate section, "3.6.3 Matilija Dam."

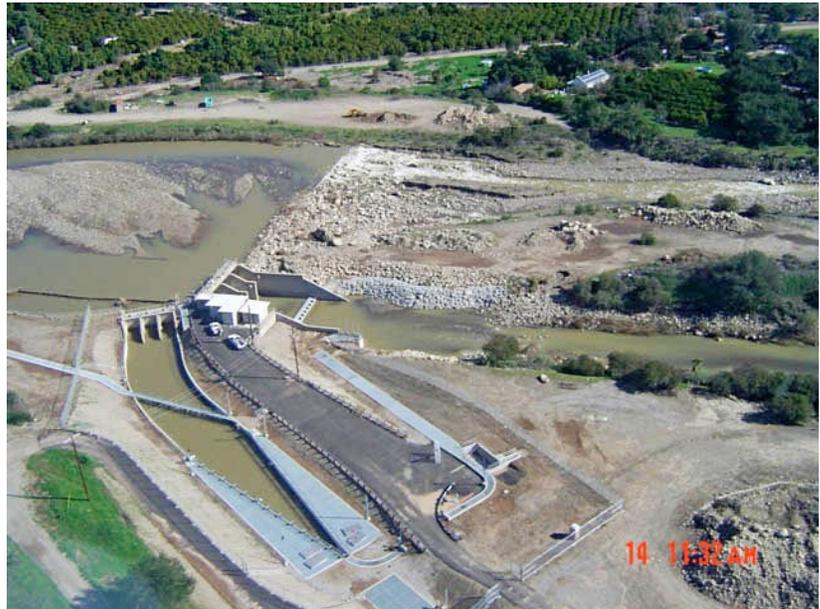
**Robles Diversion and  
Fish Passage Facility**

The cost to build the Fish Passage Facility was \$8.1 million (Lewis 2014).

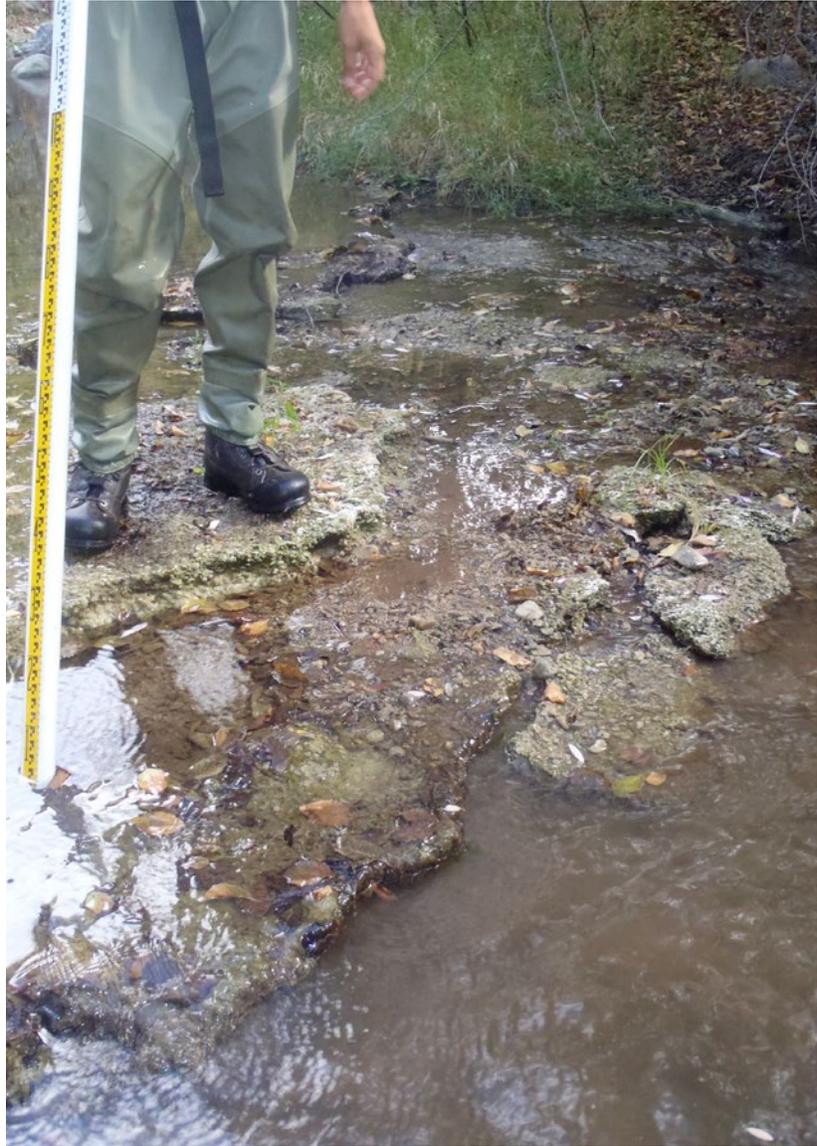
**Cemented Gravels, North Fork Matilija Creek.** Calcification cements gravels together and limits the availability of gravels needed for fish spawning.

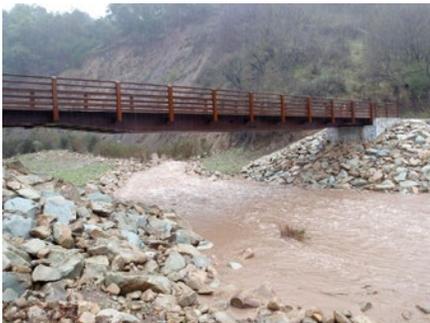
**Lion Creek Bridge Improves Fish Passage.** In 2010, a “fair weather crossing” on Lion Creek, a major tributary of San Antonio Creek, was replaced with this bridge, which improved steelhead access to over nine miles of upstream habitat. Photo courtesy of South Coast Habitat Restoration

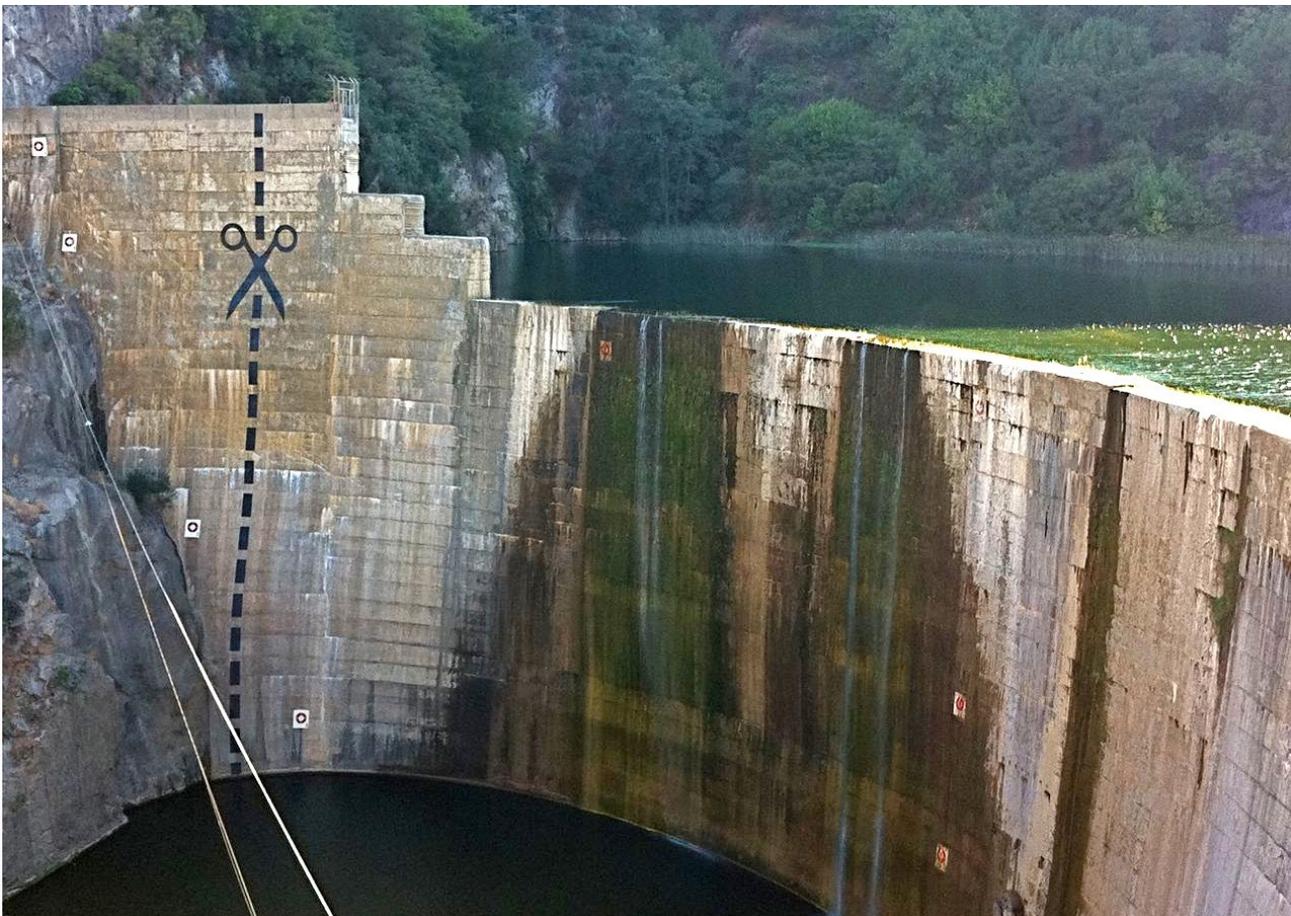
**Matilija Dam Notches.** The top of the dam was notched in 1965 and again in 1978 to address safety concerns, including strain on the dam from water stored behind the dam and deteriorating concrete. The original dam height was 198 feet and is now 168 feet (USACE 2004). In 2011, someone painted a huge pair of scissors and a long dotted line on the face of the dam.

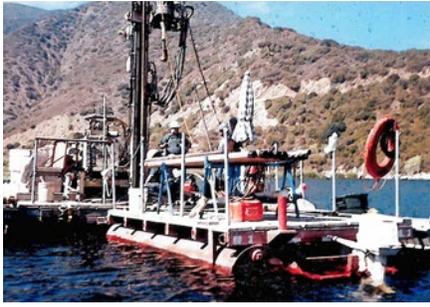
**Sampling Barge on Matilija Reservoir, 2001.** Drilling, coring, and sample collection was conducted from a barge on the reservoir to obtain subsurface data and sediment samples.
