Ventura River Watershed

Management Plan

PART 3

Watershed Characteristics

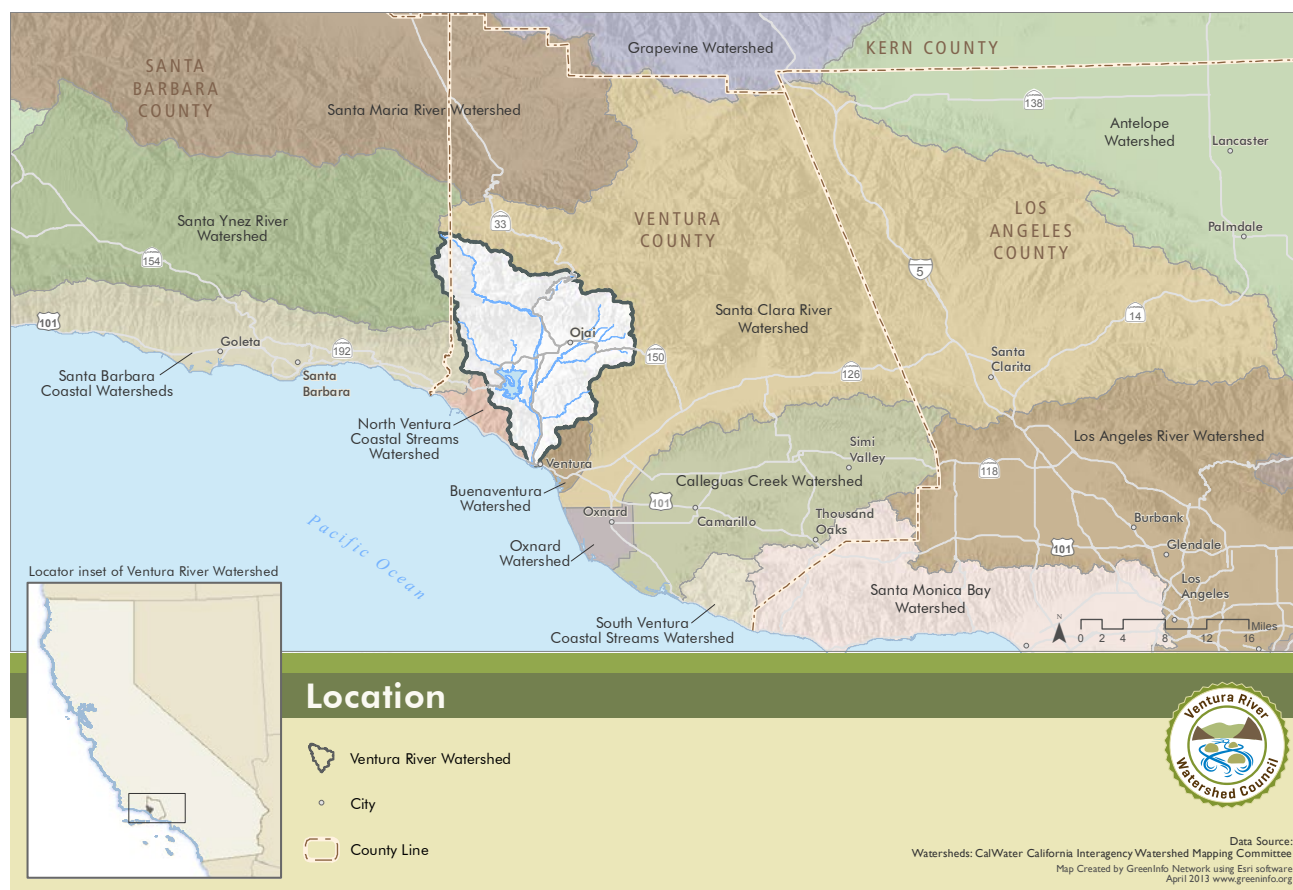
Figure 3.1.1.1 Location Map

Location: The Ventura River watershed is located in southern California, in western Ventura County, with a small section in the northwest corner located in eastern Santa Barbara County. At 226 square miles, it is the smallest of the three major watersheds in Ventura County, which are the Ventura River, Santa Clara River, and Calleguas Creek watersheds.

The watershed is fan-shaped: It measures 18 miles north to south, is 17 miles at its widest point and 1.3 miles wide at its narrowest point, the estuary.
