# Ventura River Watershed

## Management Plan

# Watershed Characteristics

## 3.1 Overview and Quick Facts

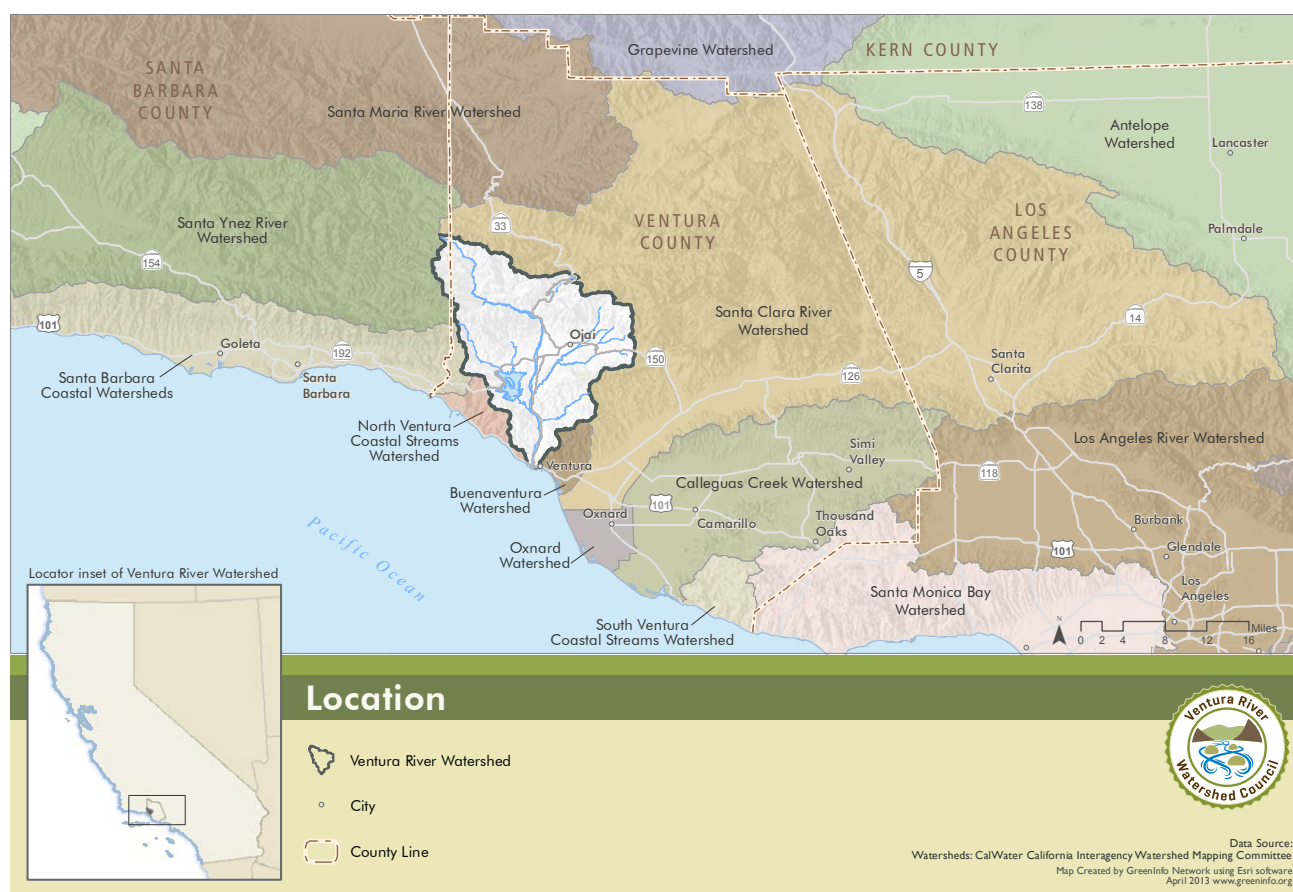
**Figure 3.1.1.1 Location Map**

**Location:** The Ventura River watershed is located in southern California, in western Ventura County, with a small section in the northwest corner located in eastern Santa Barbara County. At 226 square miles, it is the smallest of the three major watersheds in Ventura County, which are the Ventura River, Santa Clara River, and Calleguas Creek watersheds.

The watershed is fan-shaped: It measures 18 miles north to south, is 17 miles at its widest point and 1.3 miles wide at its narrowest point, the estuary.
