San Antonio Creek Spreading Grounds Rehabilitation Project Ojai Valley, CA

Presentation to
Ventura River Watershed Council

August 7, 2014

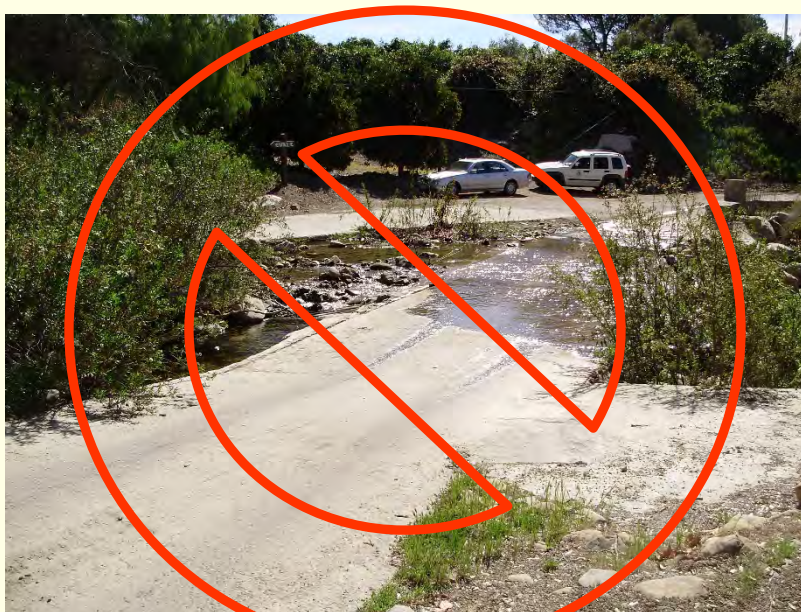
Arizona Crossing
Not Allowed

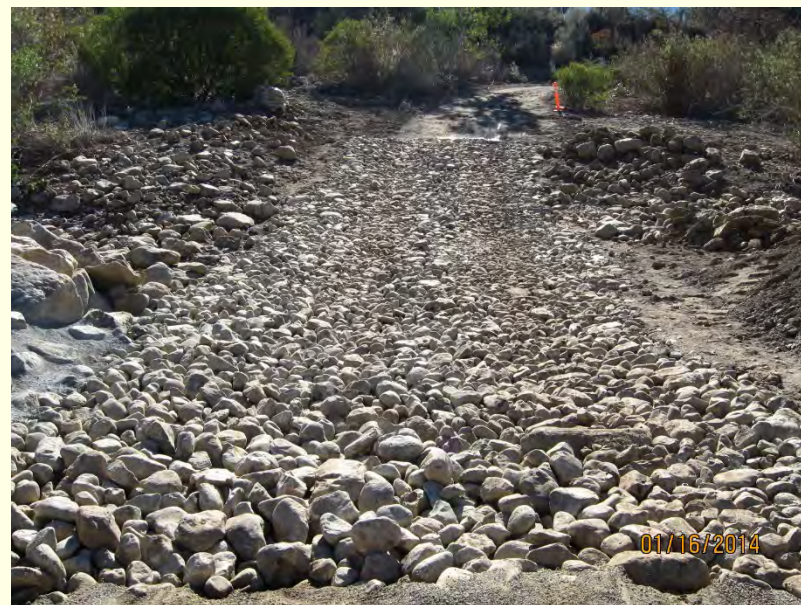
Cobble Crossing
Constructed

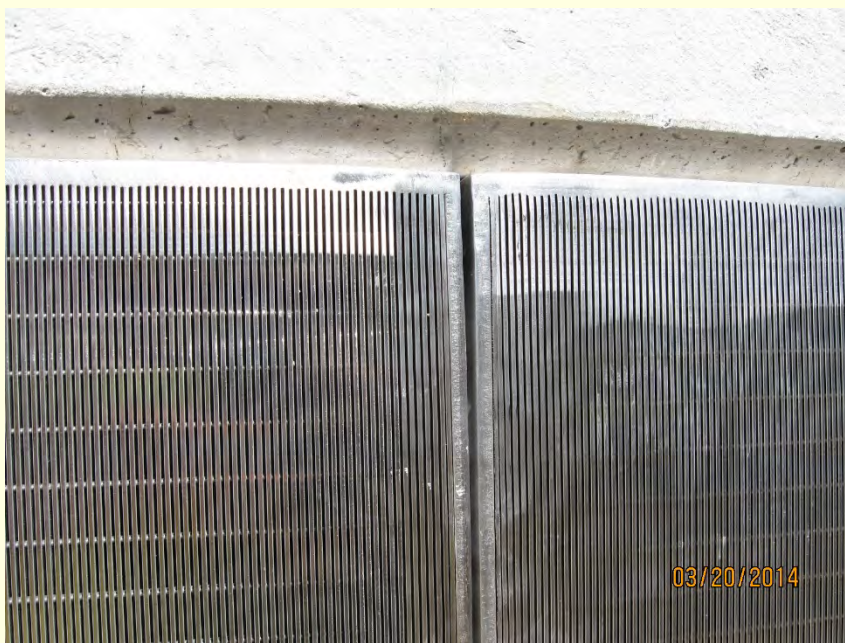
Intake Structure Fish Screen & Automatic Cleaning Device

Fish screen panels constructed of V-wire profile bar with <math><0.0689</math>-inch width openings

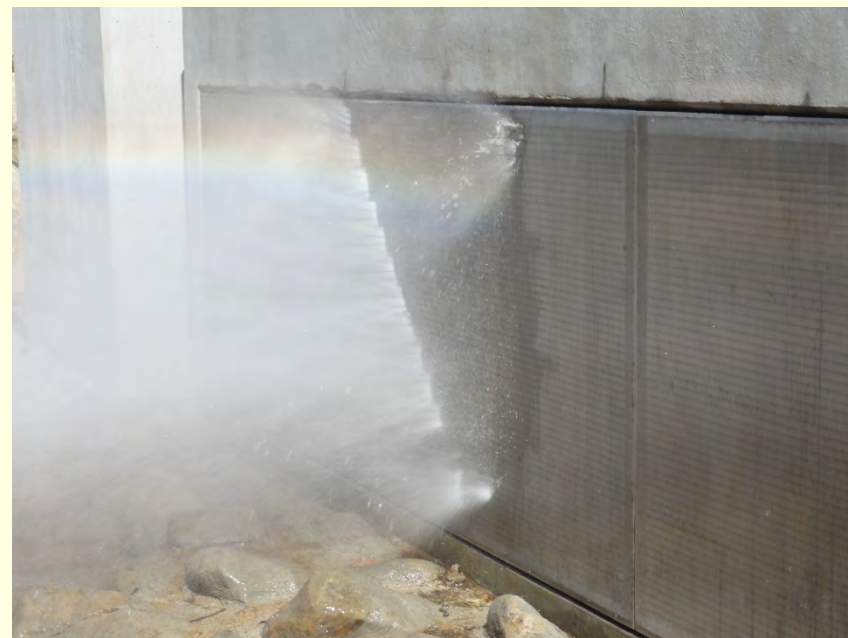
Screen cleaning device: rotating bars spray water from inside

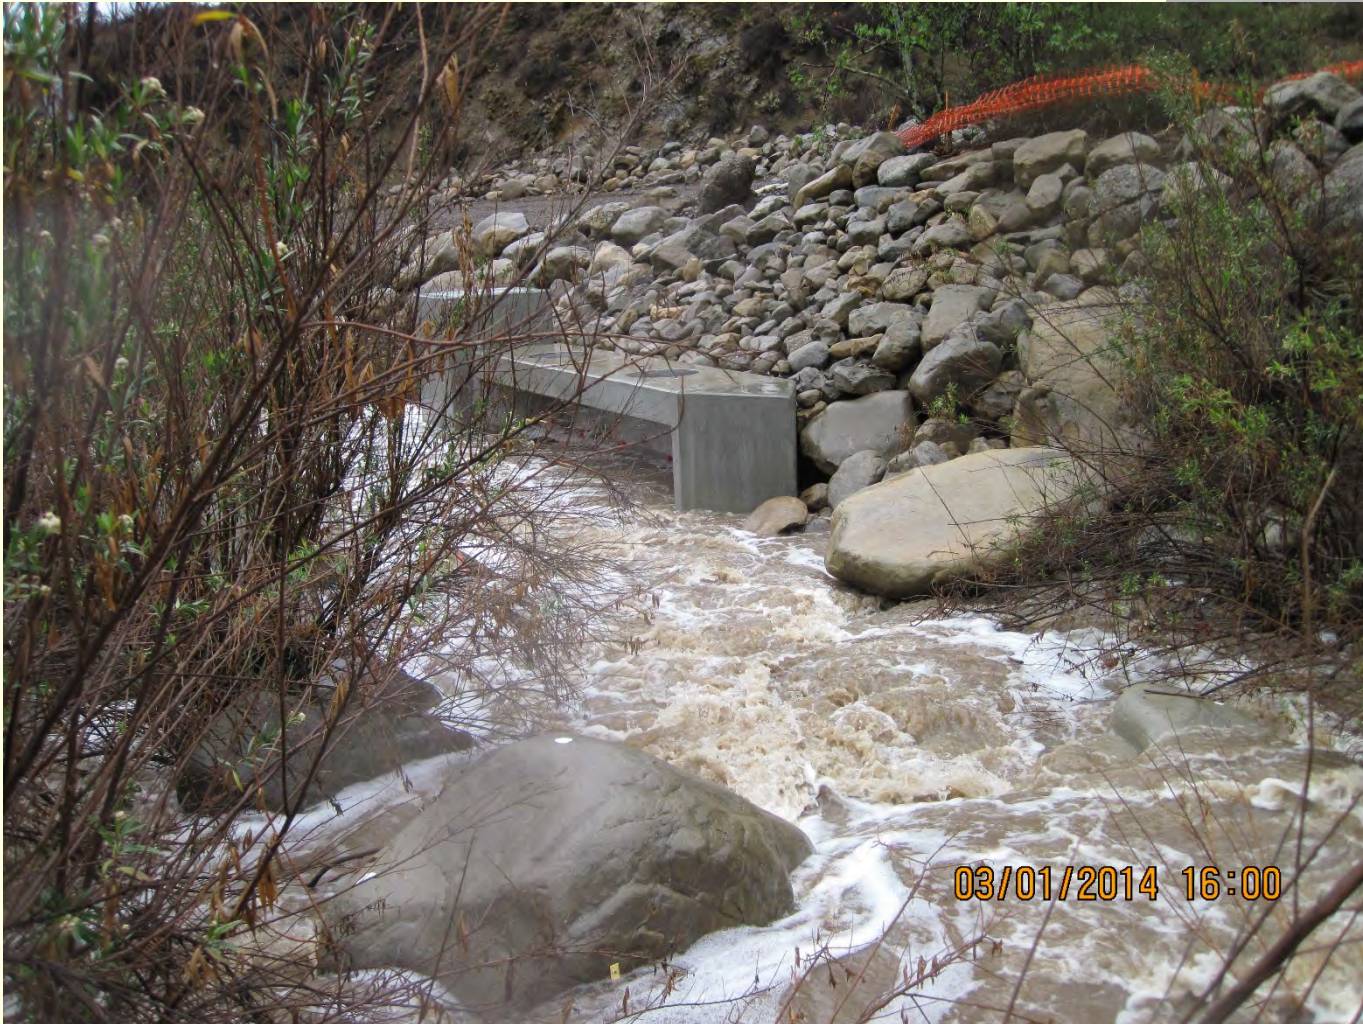
Storm Event – March 1, 2014

Approx. 80 cfs
