# 3.3 Hydrology

## 3.3 Hydrology

### 3.3.1 Surface Water Hydrology

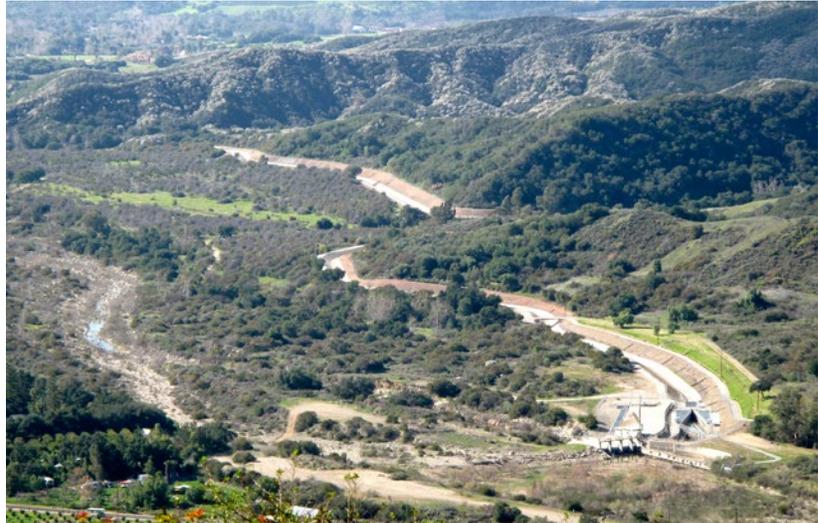
#### Robles Diversion Facility

The Robles Diversion Facility—the structure that diverts Ventura River flow to Lake Casitas—is located on the west bank of the Ventura River channel, opposite and just below where Cozy Dell Canyon Creek enters.

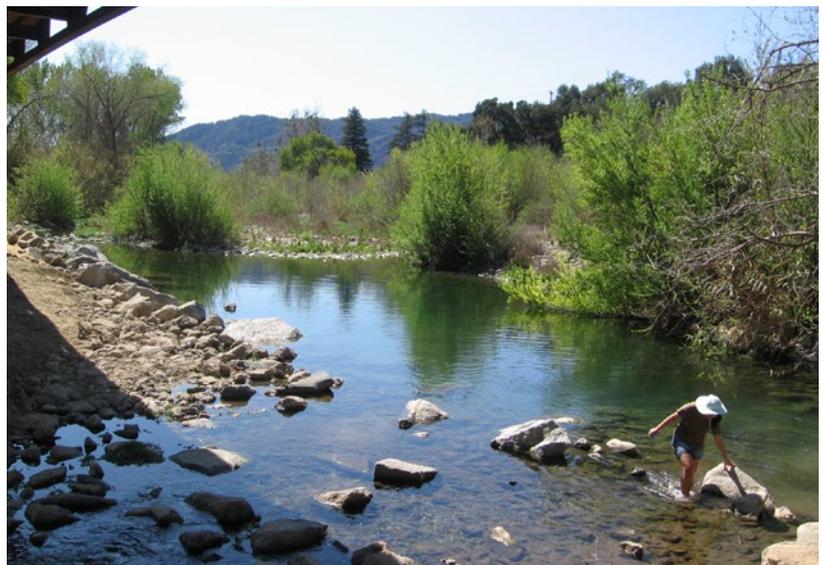
A large pool forms at the confluence of the Ventura River and San Antonio Creek, providing important habitat for fish and other animals.

#### Confluence Pool, Ventura River at San Antonio Creek. San Antonio Creek can be seen flowing into the Ventura River at the confluence pool.

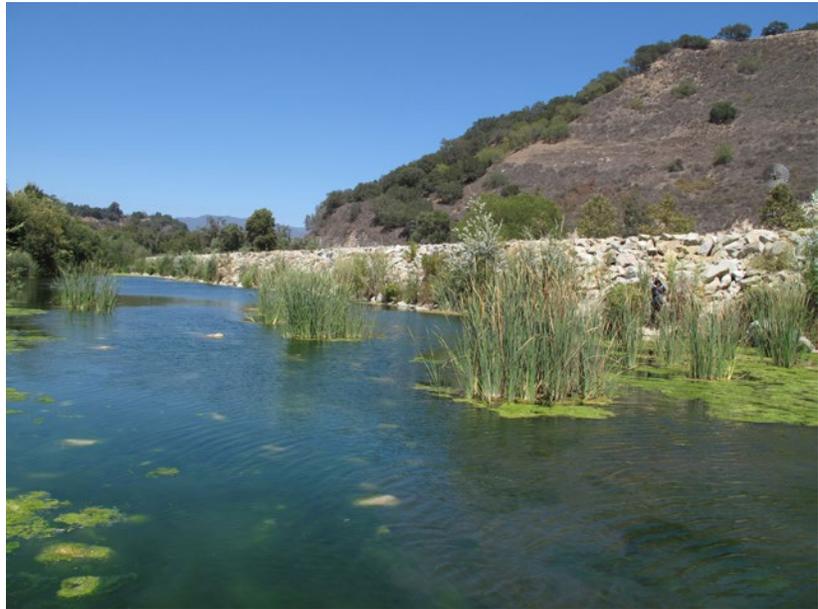
### Casitas Springs Levee and Pool

In-river groundwater springs are also found in the river as it passes through the aptly named “Casitas Springs” area below the San Antonio Creek confluence (EDAW 1978). The community of Casitas Springs is protected here by the Casitas Springs Levee.

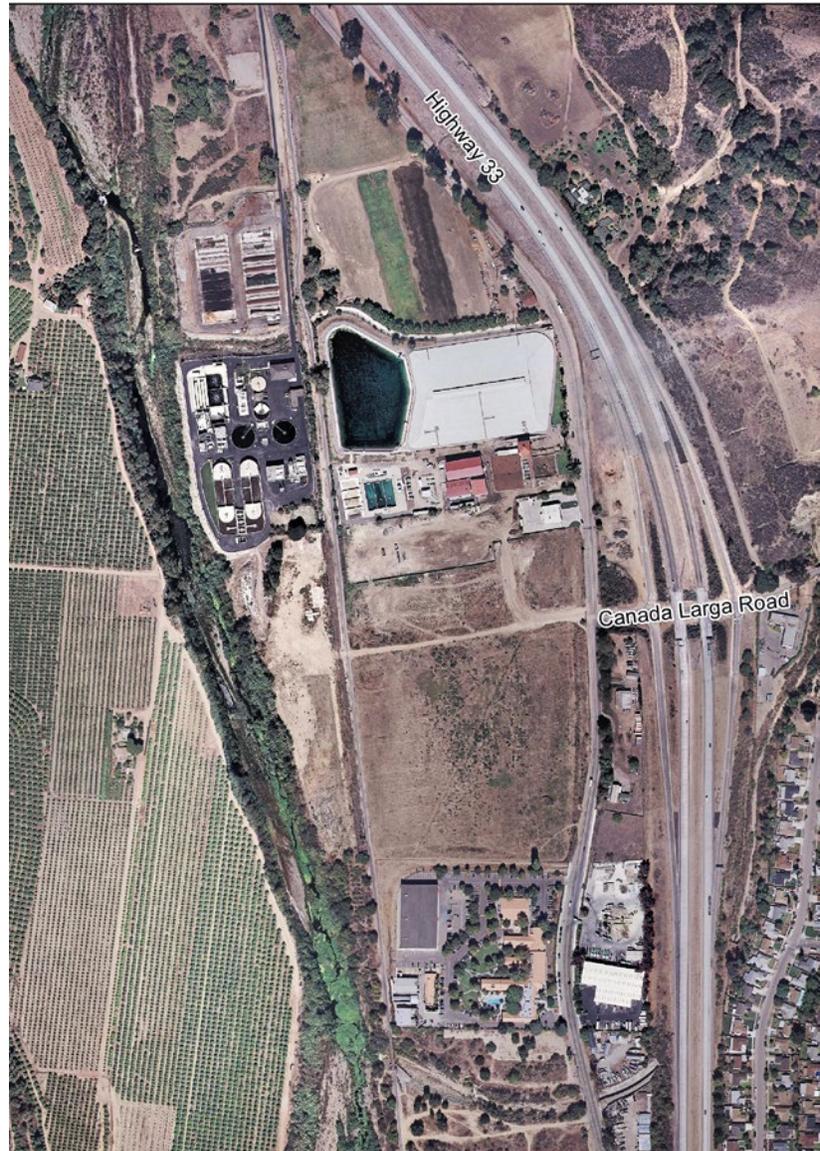
**Aerial View of Wastewater Treatment Plant.** The Ojai Valley Sanitary District's wastewater treatment plant contributes treated wastewater to the flow of the river. Located to the east of the wastewater plant is the City of Ventura's plant for treating water pulled from the river upstream at Foster Park.

Downstream from this location, the river receives treated effluent from the wastewater treatment plant. The effluent constitutes a significant input and, in many years, accounts for the perennial flow in the remaining stretch of the Ventura River.

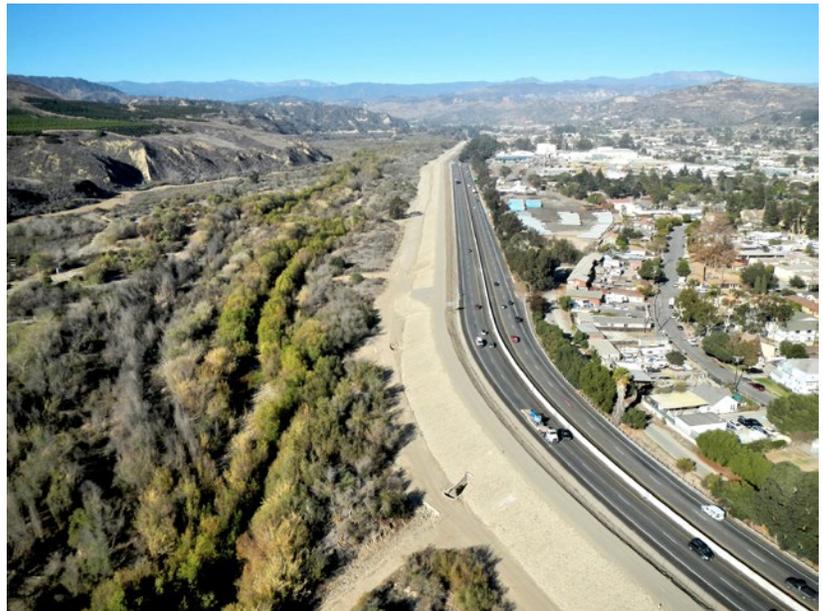
**Ventura River Levee**

Just past the wastewater treatment plant, Cañada Larga Creek enters the Ventura River from the east; the river then flows through an area of active oil production wells. Several minor drainages (Manuel Canyon Creek, Cañada de San Joaquin, and Dent Drain) flow into the river from the east in this reach. The last 2.6 miles of the river are constrained by the Ventura River Levee on the east, which protects the City of Ventura from flooding.

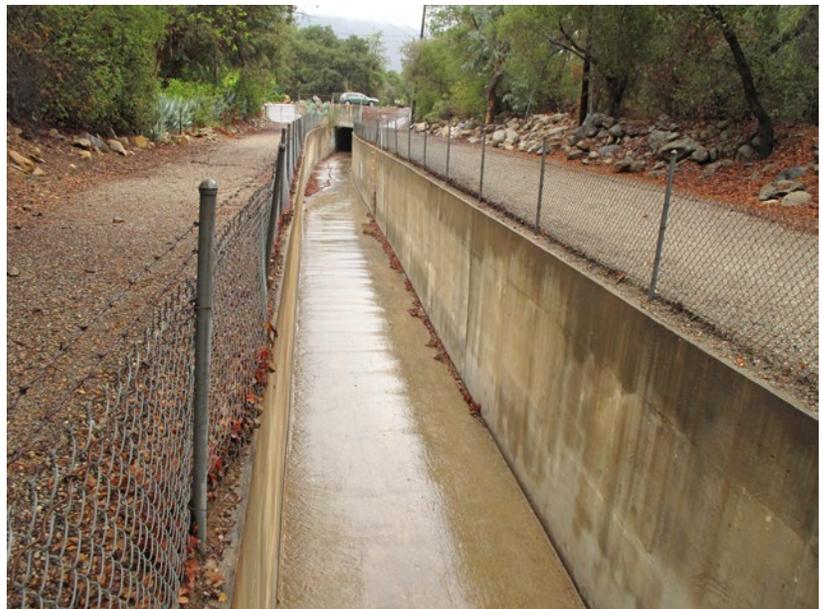
**Stewart Canyon Creek Going Underground Above Ojai**

Continuing southwest along the edge of the City of Ojai, San Antonio Creek receives flow from Stewart Canyon Creek at the beginning of Creek Road. Stewart Canyon Creek is an important drainage that flows south from the Topatopa Mountains through the City of Ojai. Much of it is underground or channelized through the City, but the lower reach, which receives flow from Fox Canyon Barranca, is primarily unchannelized and often has perennial flow (Magney 2005).

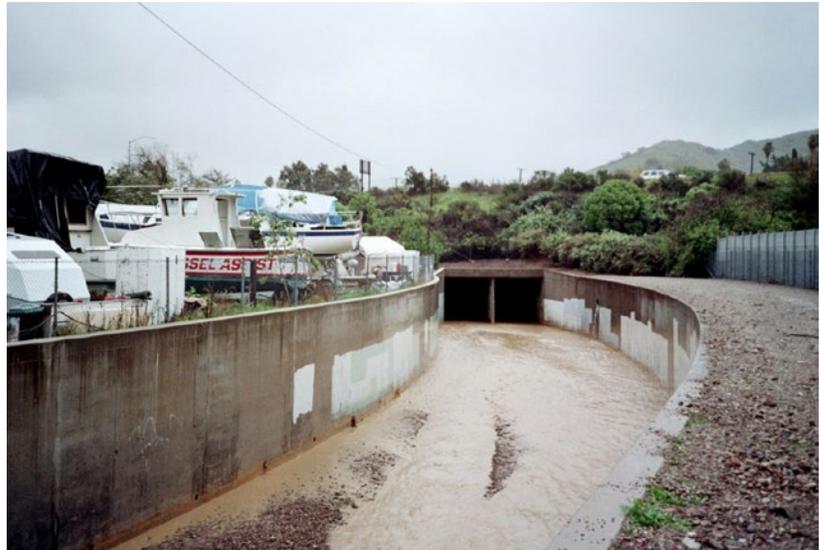
### Channelized Cañada Larga Creek

To expedite freeway construction, Cañada Larga Creek was diverted so that the streambed now makes a sharp bend where it meets Highway 33 and flows south along the east side of the highway for a stretch. A concrete channel conducts Cañada Larga Creek under Highway 33 and North Ventura Avenue and subsequently through an undeveloped field before converging with the Ventura River just above the abandoned Petrochem gasoline refinery site. Cañada Larga Creek is 7.85 miles long.

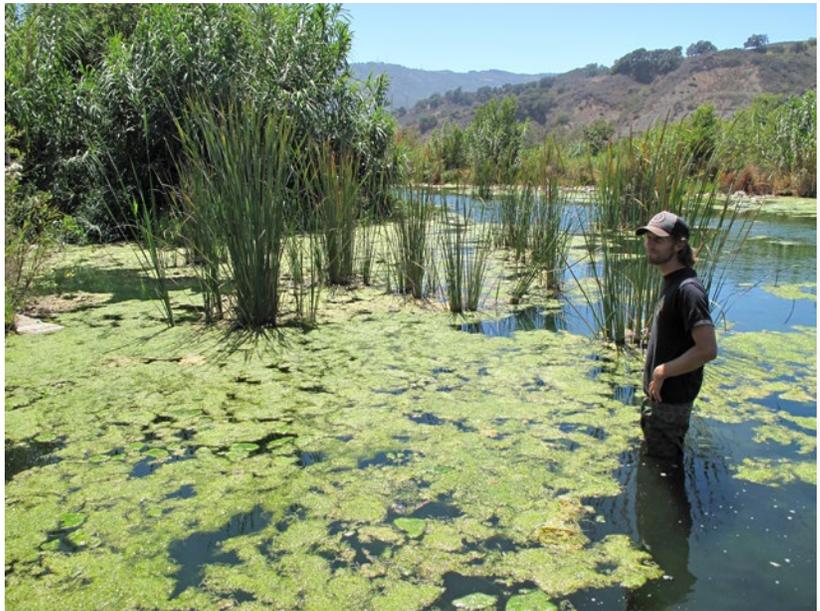
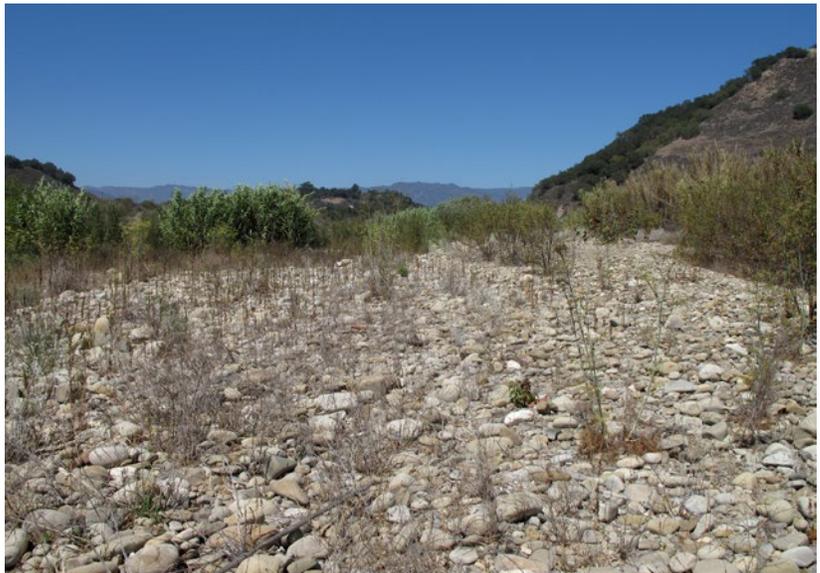
**Ventura River at Casitas Springs, Very Wet and Very Dry.** Both of the photos above were taken on August 14, 2013, in the Ventura River at Casitas Springs. The lake-like pool was next to the levee immediately adjacent to the Casitas Springs Mobile Home Park (top); about 400 feet downstream, the main channel of the river disappeared underground (bottom).

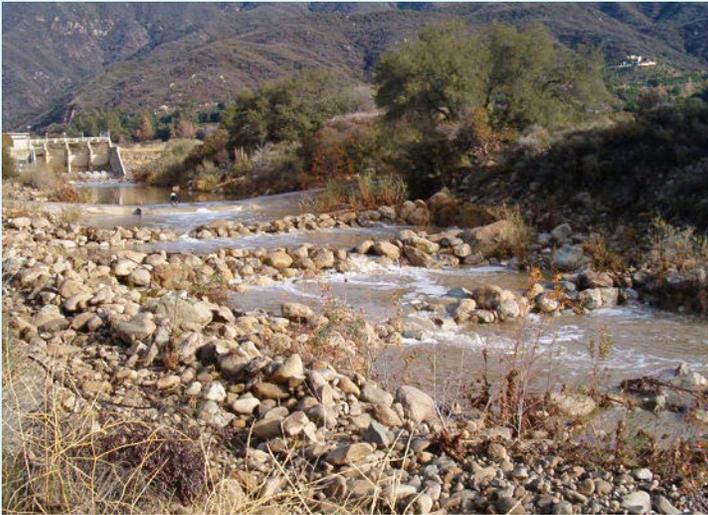
#### 35 and 200+ CFS of Streamflow, Ventura River, Below Robles Diversion.

These photos are intended to show what different rates of flow (cubic feet per second, or cfs) look like. The top photo shows a flow of about 35 cfs and the bottom photo, a flow 200+ cfs.

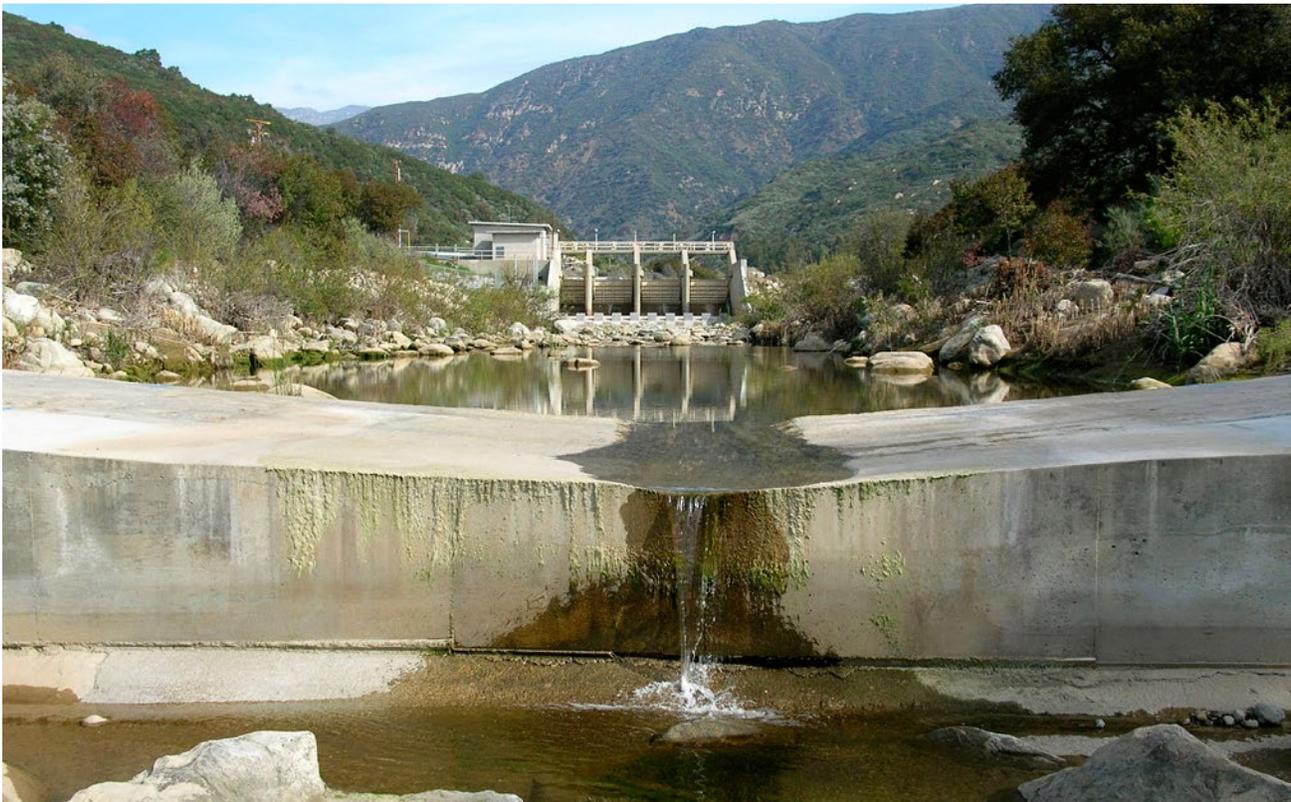
**Robles Diversion.** The Robles Diversion structure is located 1.5 miles downstream of the confluence of Matilija and North Fork Matilija Creeks, the beginning of the Ventura River. The concrete structure is located on the western bank of the river, and has diversion gates, bypass gates, and a fish ladder. A 350-foot-long by 9.5-foot-high earthen dam is located across the river to divert flows to the diversion structure (Entrix & Woodward Clyde 1997). Both photos were taken during the dry season when no water diversions were occurring.

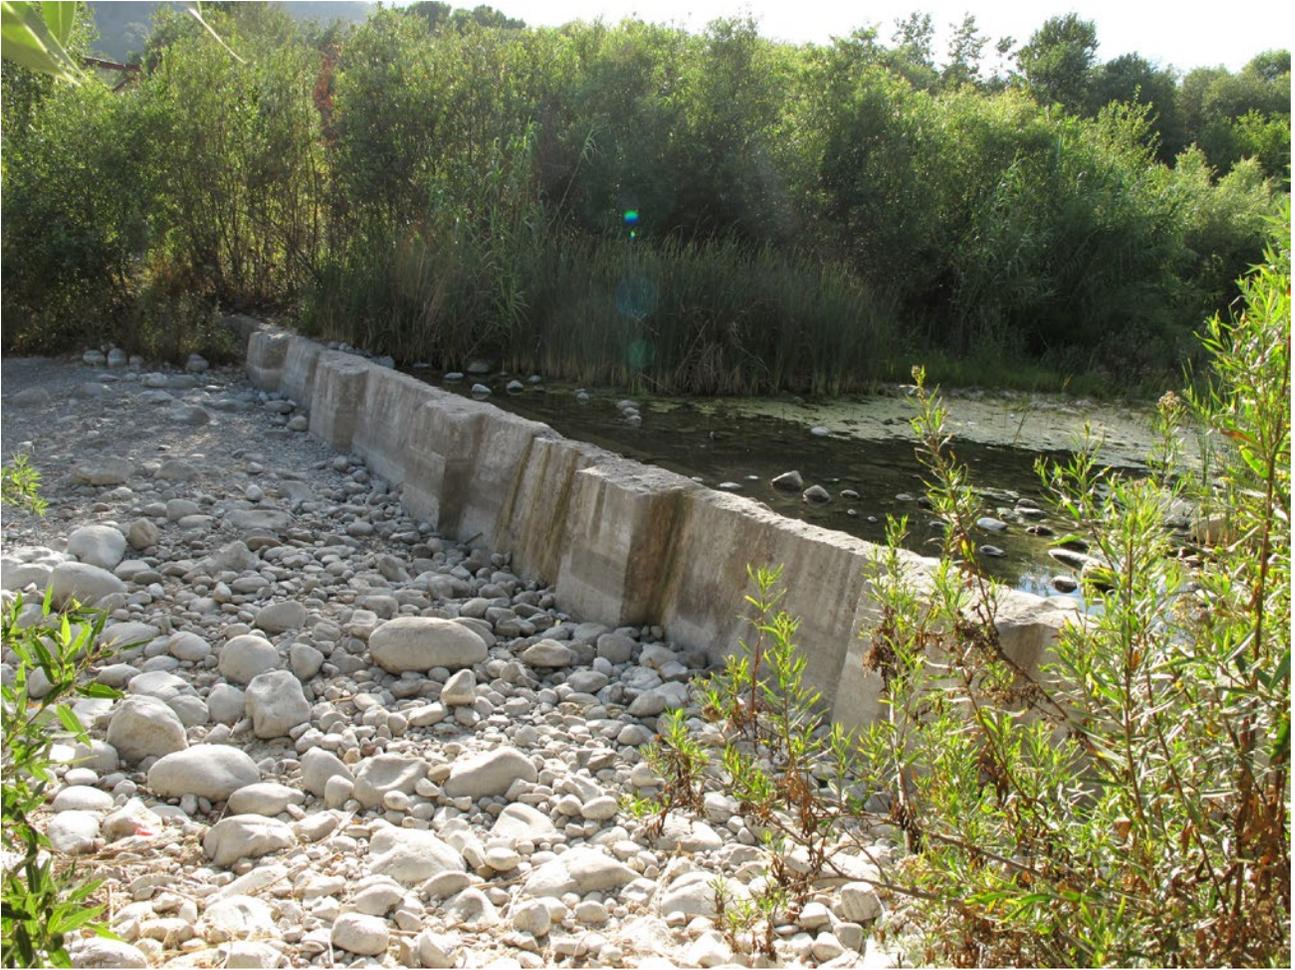
**Foster Park Subsurface Dam and Diversion, August 2013.** This photo was taken in August after two dry winters.

A small dam also exists in the Ventura River at Foster Park. This is an area of the river that naturally has regular flow, in part because underground geologic structures force subsurface flow to the surface. In 1906, this natural geologic feature was enhanced by construction of a subsurface diversion dam across the river to enhance the amount of water available for diversion to the City of Ventura. The dam crosses the Ventura River as well as the mouth of Coyote Creek (Entrix & Woodward Clyde 1997), and works in combination with subsurface collector pipes.

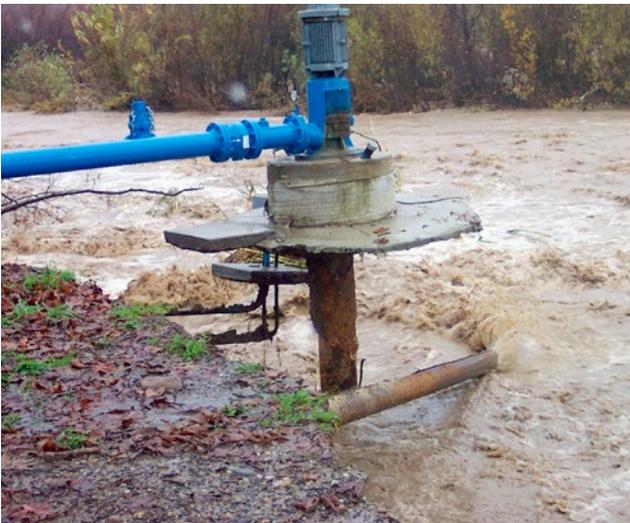
**City of Ventura's Nye Well 1A, 2005 Flood.** The City's Nye Well 1A replaced Nye Well 1, lost in a previous flood. The February 2005 flood took out the rest of its replacement.

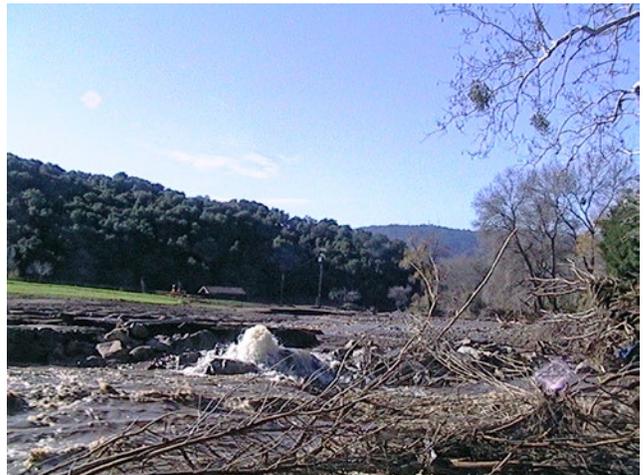
**Overflowing Manhole in San Antonio Creek, 2005 Flood.** Stormwater caught in the sewer system flows out the manhole.

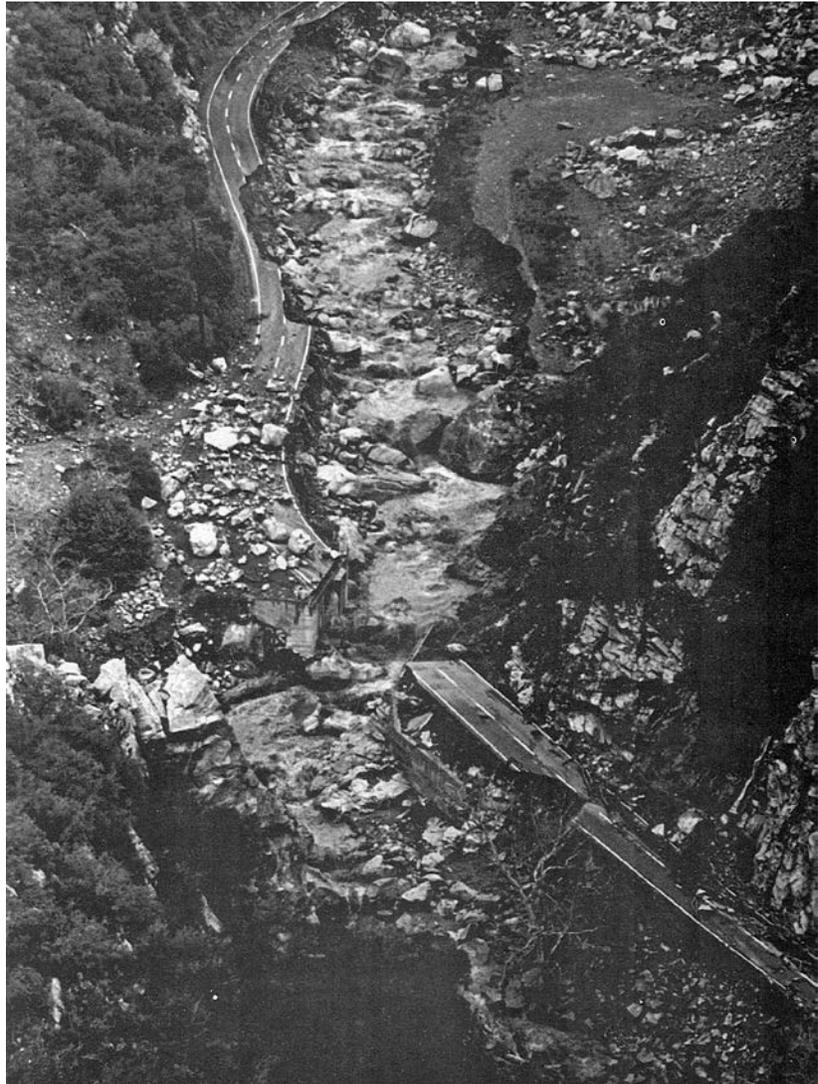
#### **Highway 33 Destroyed at North Fork Matilija Creek, 1969**

The most damaging riverine flood recorded in the Ventura River watershed occurred in 1969. The watershed above Ojai received a staggering 43 inches of rain in nine days between January 18 and January 27. The floodwaters and associated debris rolled down out of the mountains, flooding homes in Casitas Springs and Live Oak Acres. Much agricultural land, primarily citrus groves, was seriously damaged or destroyed. All over Ventura County, transportation facilities, including roads, bridges, and railroad tracks, were damaged. The wastewater treatment plant below Foster Park was severely damaged and dumped raw sewage into the Ventura River. In addition, sewer trunk lines were broken along the Ventura River and San Antonio Creek. Untreated sewage polluted the river and beach (VCPD 2011a). The capacity of the Matilija reservoir was significantly reduced by siltation from the flood (USACE 2004). See "4.4 Appendices" for a more detailed description of the 1969 flood.

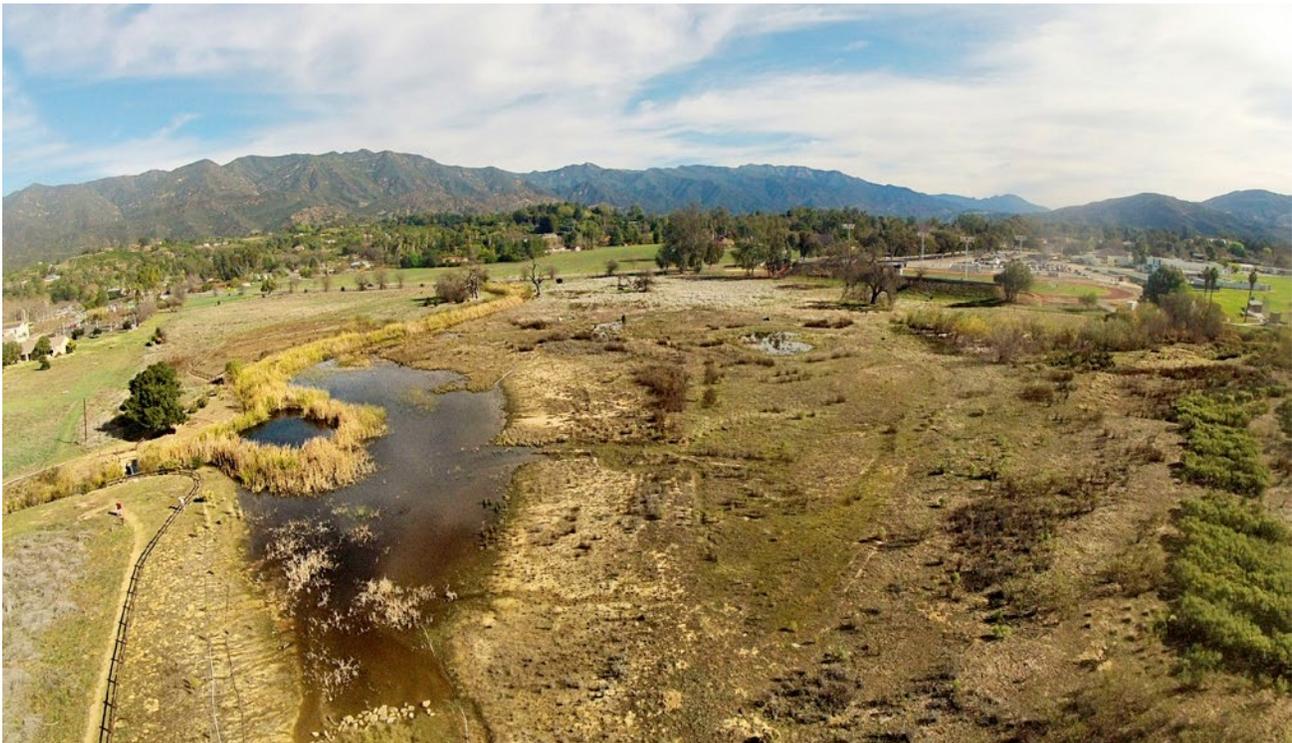
**Ojai Meadows Preserve Flood Management Wetland.** The restoration of the Ojai Meadows Preserve in Meiners Oaks by the Ojai Valley Land Conservancy is addressing a historic urban drainage problem by re-establishing the natural wetland drainage in that area.

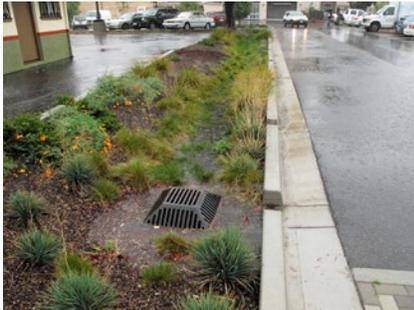
**Bioswale, Oak Street Parking Lot, Ventura**

As a result of these impacts to water quality, state and local regulators have developed stormwater “best management practice” (BMP) programs and requirements to increase the retention and infiltration of stormwater onsite, so that the amount and quality of water leaving the site during storms more closely matches that of predevelopment conditions. These BMPs include bioswales, rain gardens, vegetated filter strips, small neighborhood retention basins, and other types of infiltration systems (and curb cuts that direct runoff into these infiltration systems), as well as pervious pavements, green roofs and other systems. The photos below illustrate some of these systems installed in the watershed.

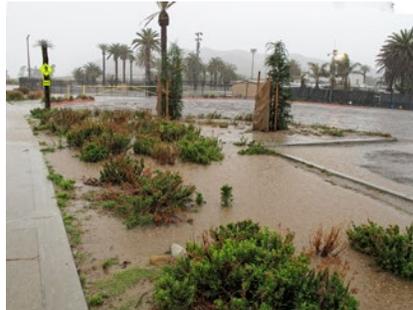
**Bioswale, Surfers' Point, Ventura**

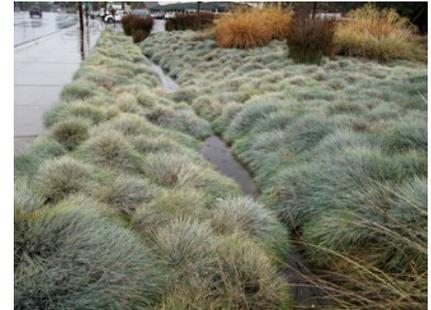
**Bioswale, Hwy 33, Mira Monte**

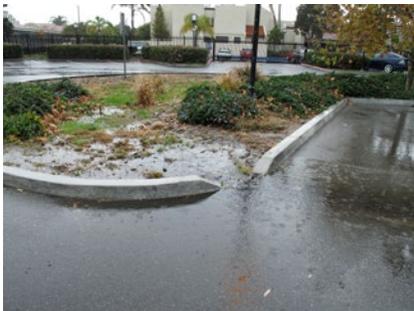
**Bioswale, Downtown Ventura Parking Lot**

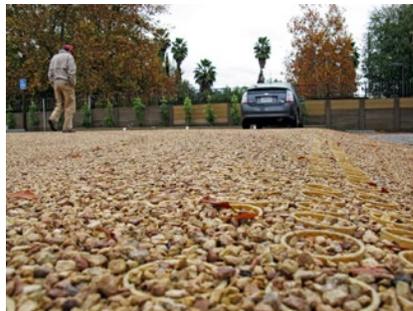
**Pervious Parking Lot, Ojai**  
Photo courtesy of Lisa Brenneis

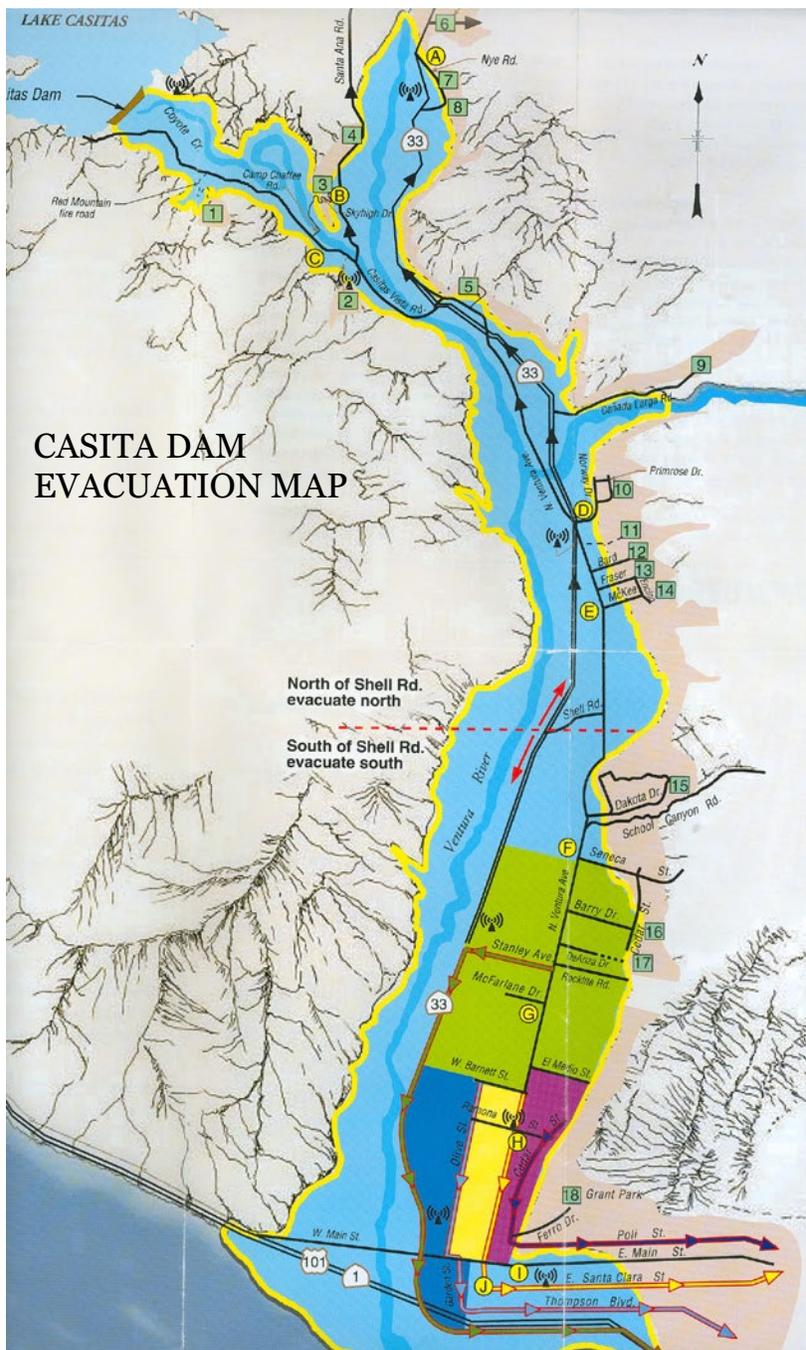
**Figure 3.3.2.3.4 Casitas Dam Evacuation Map.** For the complete map, with legend and instructions, go to <http://readyventuracounty.org/pdf/CasitasDamEvacuationMap.pdf>  
 Source: Casitas Dam Evacuation Route (VCOES 2013)

In Ventura County, disaster coordination and planning is the responsibility of the Sheriff's Office of Emergency Services (OES). The OES serves as the depository for Ventura County's Dam Inundation Maps and is charged with ongoing maintenance of the County's Dam Failure Response Plan (VCPD 2011a).

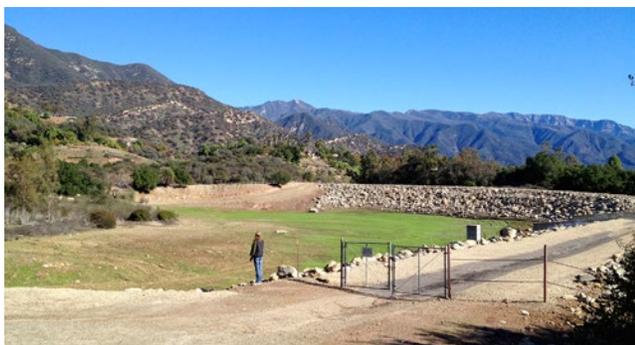
Stewart Canyon Debris Basin, Dry

This flood provided motivation for the construction of the Stewart Canyon Debris Basin, which is credited with saving the City of Ojai from major property damages and loss of lives. It is estimated that over 200,000 cubic yards of material were deposited in the basin during the storms in January and February of 1969 (City of Ojai 1991).

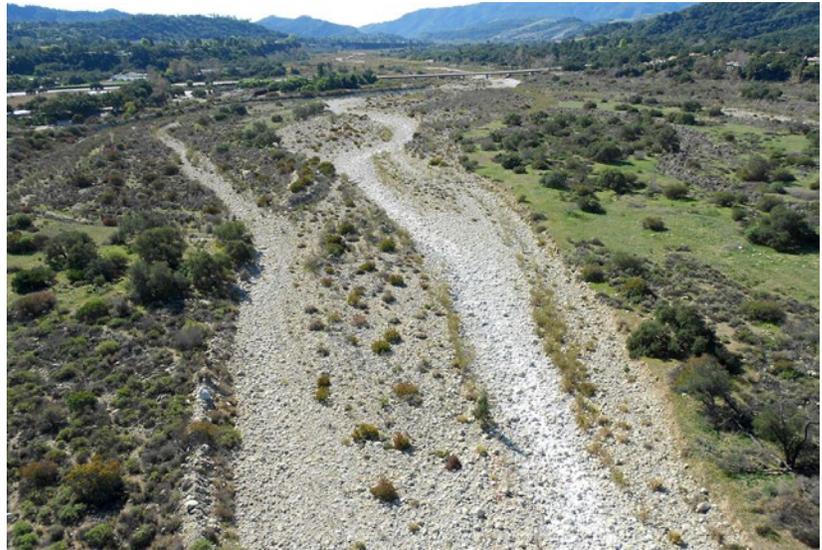
### Ventura River Dry Reach above Highway 150 Bridge

Geographically, this dry reach is where boulders, cobbles, and sediments that have been eroded from the tallest mountains in the watershed are deposited as the gradient flattens and storm flows spread out. Water rapidly filters down through this coarse material to the groundwater basin below.

Groundwater flows through the alluvium from north to south, following the surface drainage and the slight but relatively consistent gradient of the basin (SWRCB 1956). Well logs and historic accounts of rising water above the Highway 150 bridge and above where the Santa Ana Fault crosses the river suggest that the fault slows the flow of underground water (VCFCB 1971); however, this phenomena remains to be studied. The Ventura River Water District's wells are located in this area to take advantage of this potential effect.

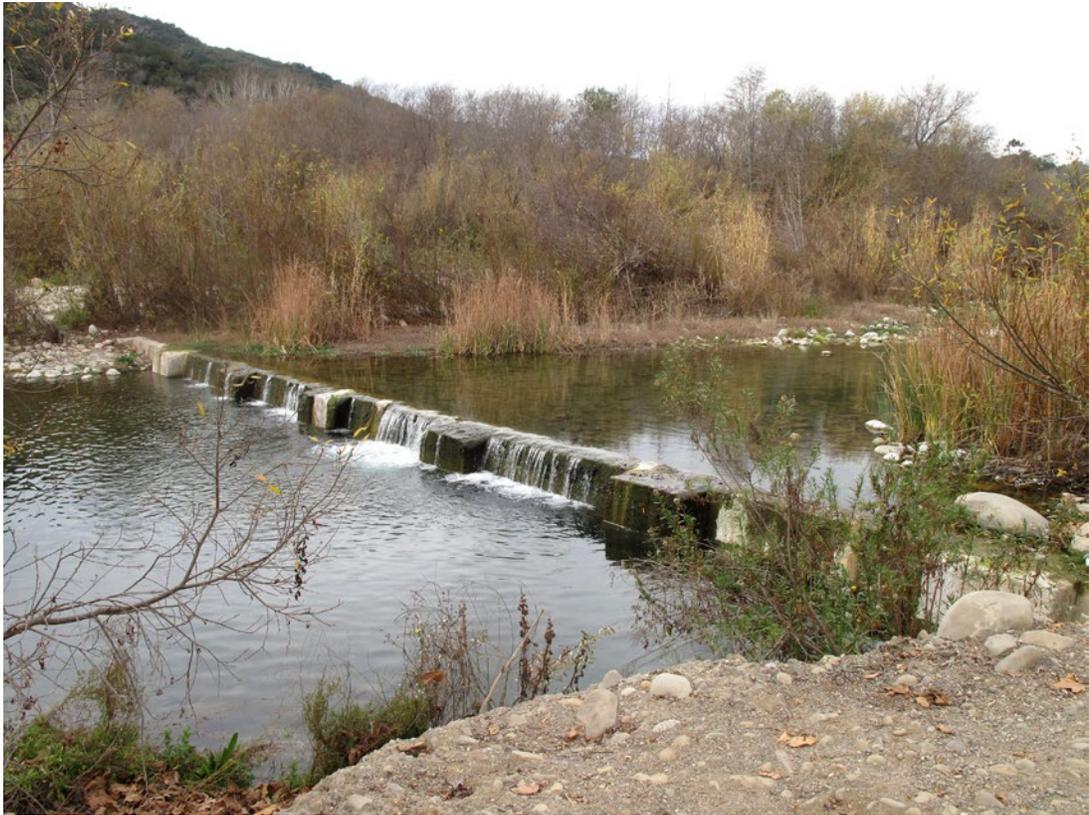
**City of Ventura’s Subsurface Diversion Structure at Foster Park.** The diversion dam slows the flow of subsurface water downstream. The City of Ventura extracts water at the structure and also has a number of wells just upstream.
