3.5 Water Quality

3.5.1 Surface Water Quality

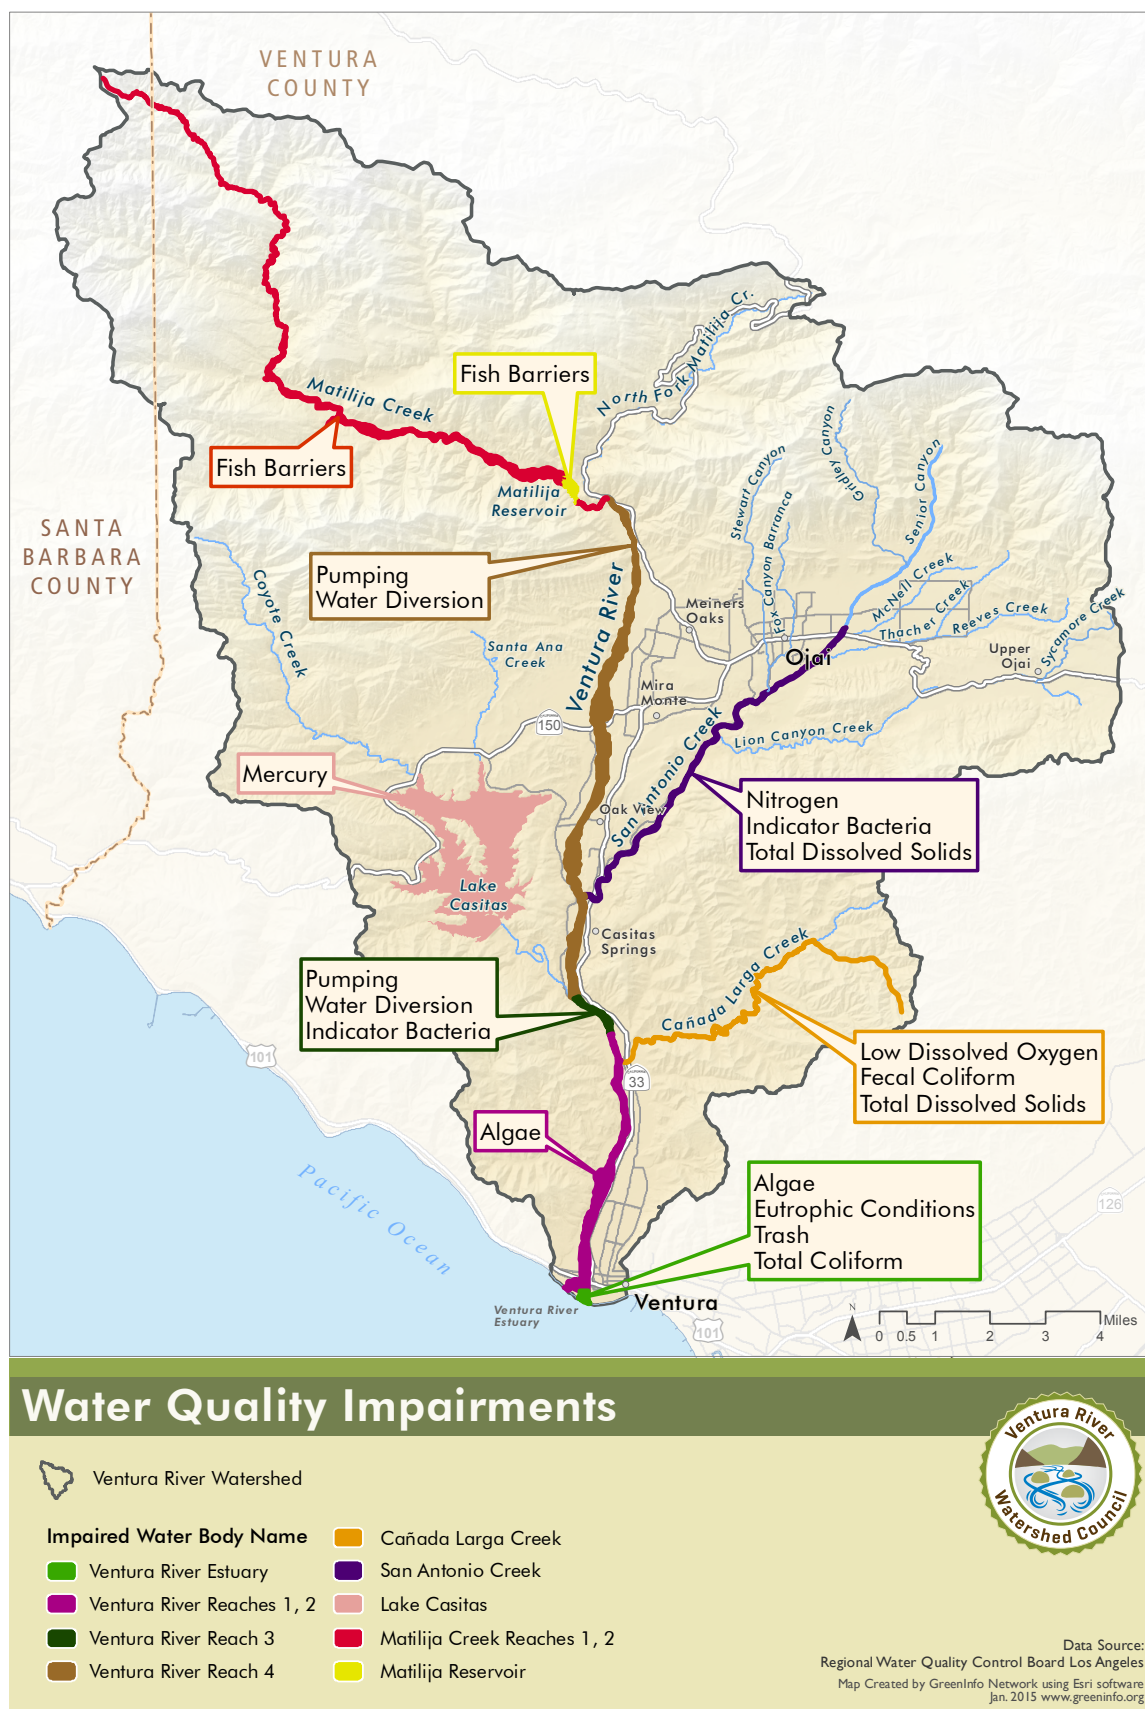
Figure 3.5.1.1.1 Water Quality Impairments Map

Source: Regional Water Quality Control Board – Los Angeles, 303(d) List of Impaired Waterbodies

San Antonio Creek, Ventura River Reaches 1, 2, and 4, Cañada Larga, and the estuary are on the list for issues related to nutrient pollution: low dissolved oxygen, excessive nitrogen, or eutrophic conditions. See Figure 3.5.1.1.1 (Water Quality Impairments Map) for an illustration of the river reaches and Table 3.5.1.5.1 (Water Quality Impairments by Waterbody) for a description of the river reaches.

Adequate streamflow is as essential for aquatic life and recreational uses as adequate water quality. Reaches 3 and 4 of the Ventura River (see Figure 3.5.1.1.1) are on the Section 303(d) list of impaired waterbodies for pumping and water diversion because the lack of water in these reaches is believed to interfere with the migration of the endangered southern California steelhead. Reach 4 includes the river’s “dry reach,” the widest and most porous part of the river where surface water often disappears underground after storm flows have passed.

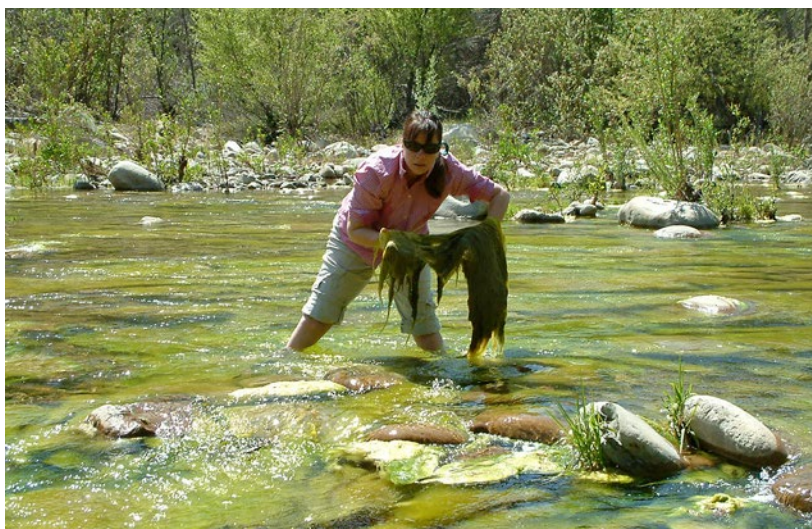
Researcher Studying Algal Bloom (*Cladophora*) in Matilija Creek, March 2010. Location: 1.5 miles above Matilija Dam, in the relatively undeveloped headwaters of the Ventura River. Algae are naturally occurring, even in the undeveloped upper watershed, where nitrate concentrations are low.

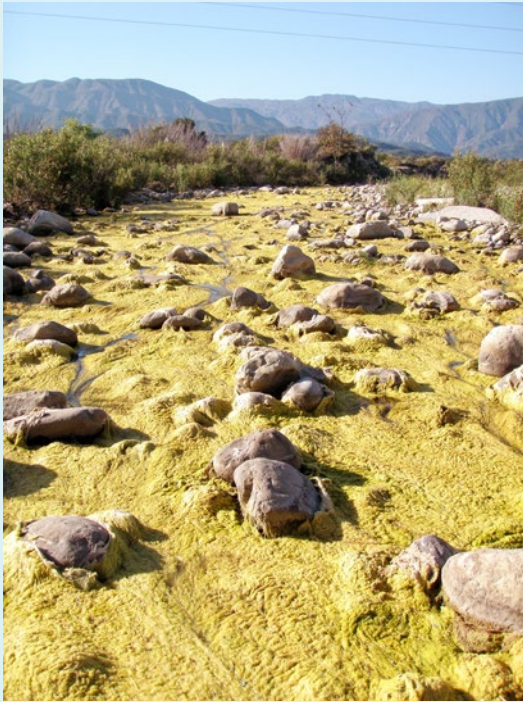
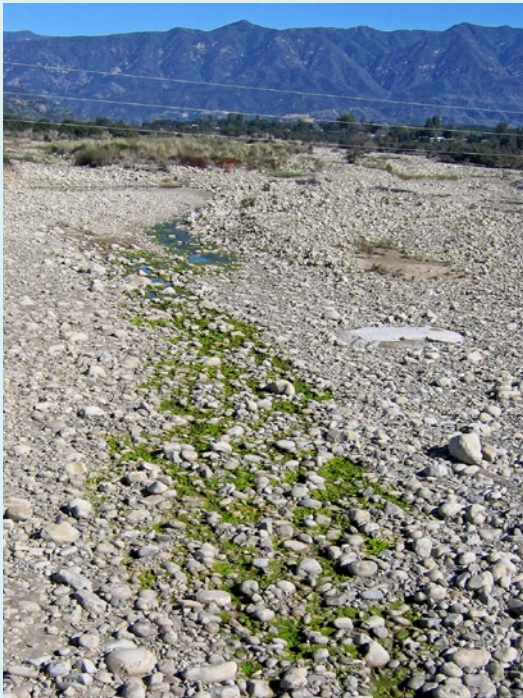
Algae Growth Can Vary Significantly in Different Years

Top left: Above Highway 150 Bridge in 2008, a big algae year. Photo courtesy of Santa Barbara Channelkeeper. "2008 was a very big algae year in the watershed. Big algal years invariably follow winters with above-average rainfall, winters with at least one storm big enough to sweep aquatic plants and accumulated fine sediment out to sea; even better if that storm is large enough to also clean out riparian growth. These storms create near-perfect algal habitat by: 1) opening up the channel to increased sunlight (sunlight to power photosynthesis—even more sunlight if riparian vegetation is cut back or removed); 2) removing competitors (for sunlight, e.g., aquatic plants) and algal parasites; 3) scouring the stream or river bottom leaving only gravel or cobble (providing necessary holdfasts—anchoring points—for *Cladophora*, the dominant alga during big blooms); and 4) increasing flow (expanding available habitat and providing for more rapid delivery of stream-borne nutrients to stationary algae)." (Leydecker 2012b)

Bottom left: Above Highway 150 Bridge in 2006, following the big storm year of 2005.

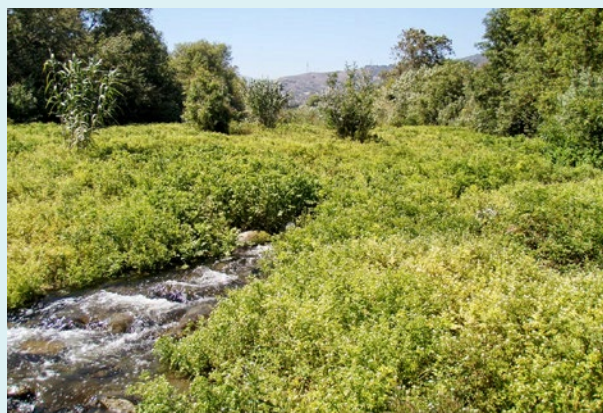
Below: Abundant aquatic plants outcompete algae downstream of Ojai Valley Sanitary District effluent discharge, 2009. This site exhibited little algae growth in May 2009 due to the abundant growth of aquatic plants that outcompeted algae for substrate and reduced sunlight to the flowing channel.

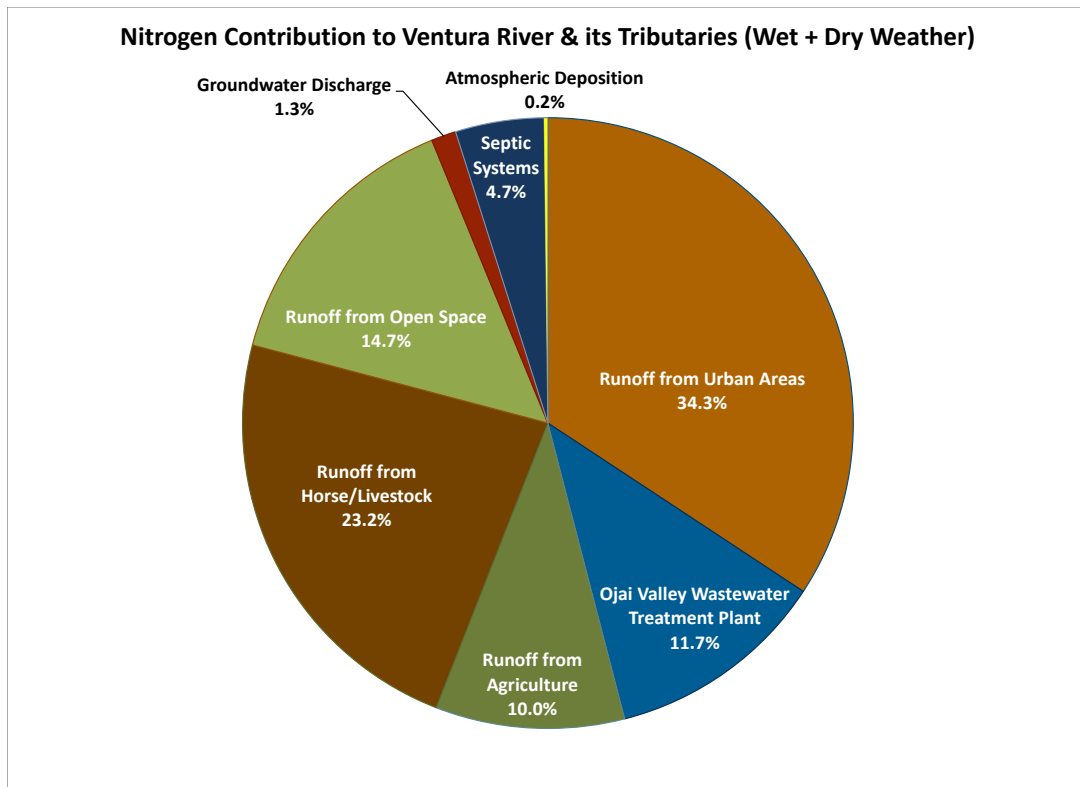
Figure 3.5.1.1.2 Total Nitrogen (TN) Contribution Estimated by Source. Further studies are needed to improve the accuracy of estimates of the relative contributions of nitrogen by source.

Source of data for chart: Algae Total Maximum Daily Load (TMDL) Regulation Staff Report (RWQCB-LA 2012)

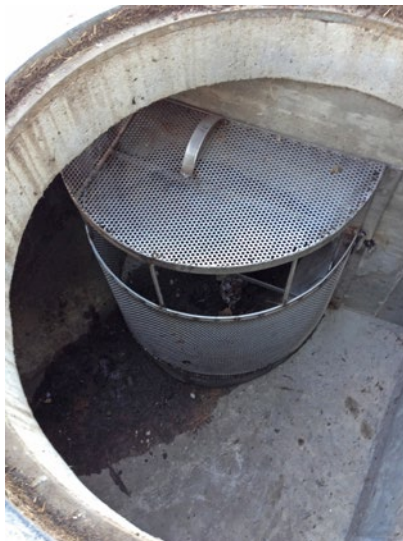
Trash Excluder. New trash excluders that prevent trash from entering the storm drain system have been installed on storm drains throughout the watershed.

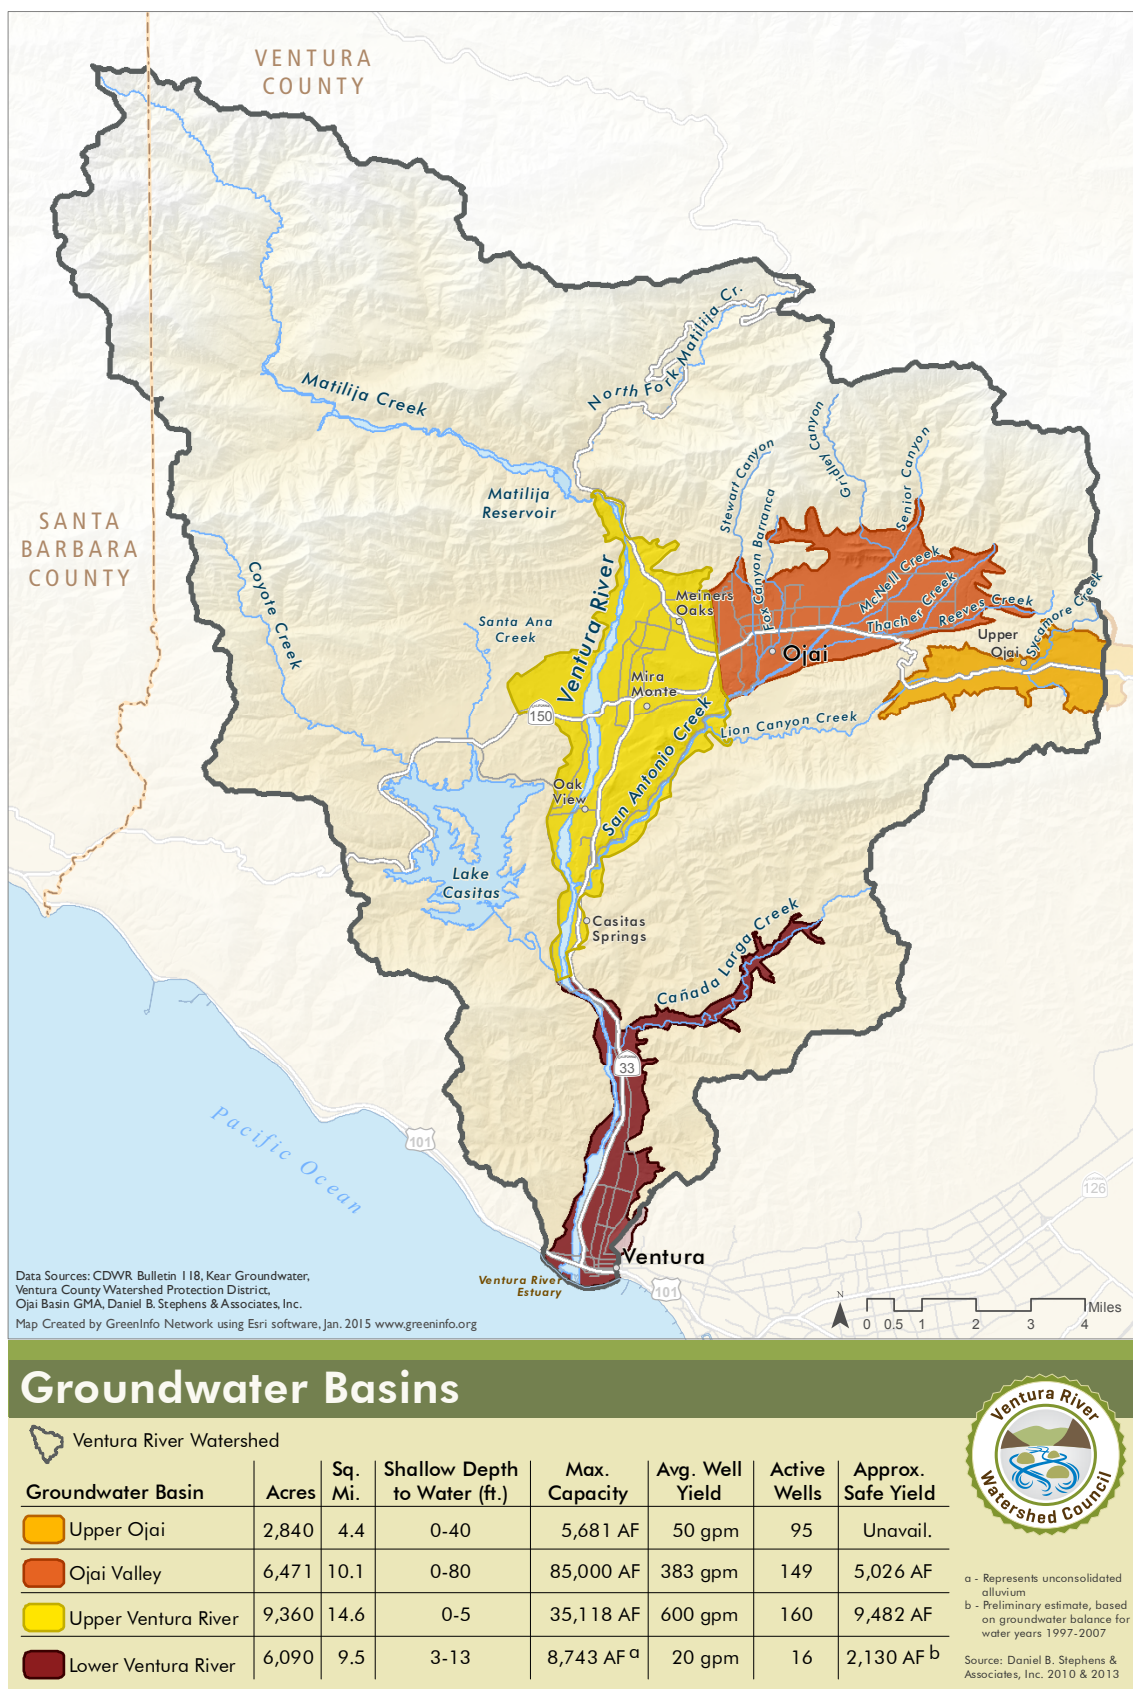
Figure 3.5.2.1 Groundwater Basins Map. Groundwater Well, Upper Ventura River Floodplain. After withdrawal, local water suppliers filter, disinfect, and sometimes blend groundwater with water from Lake Casitas before delivering it to consumers. (ft - feet; gmp - gallons per minute; AF - acre-feet)

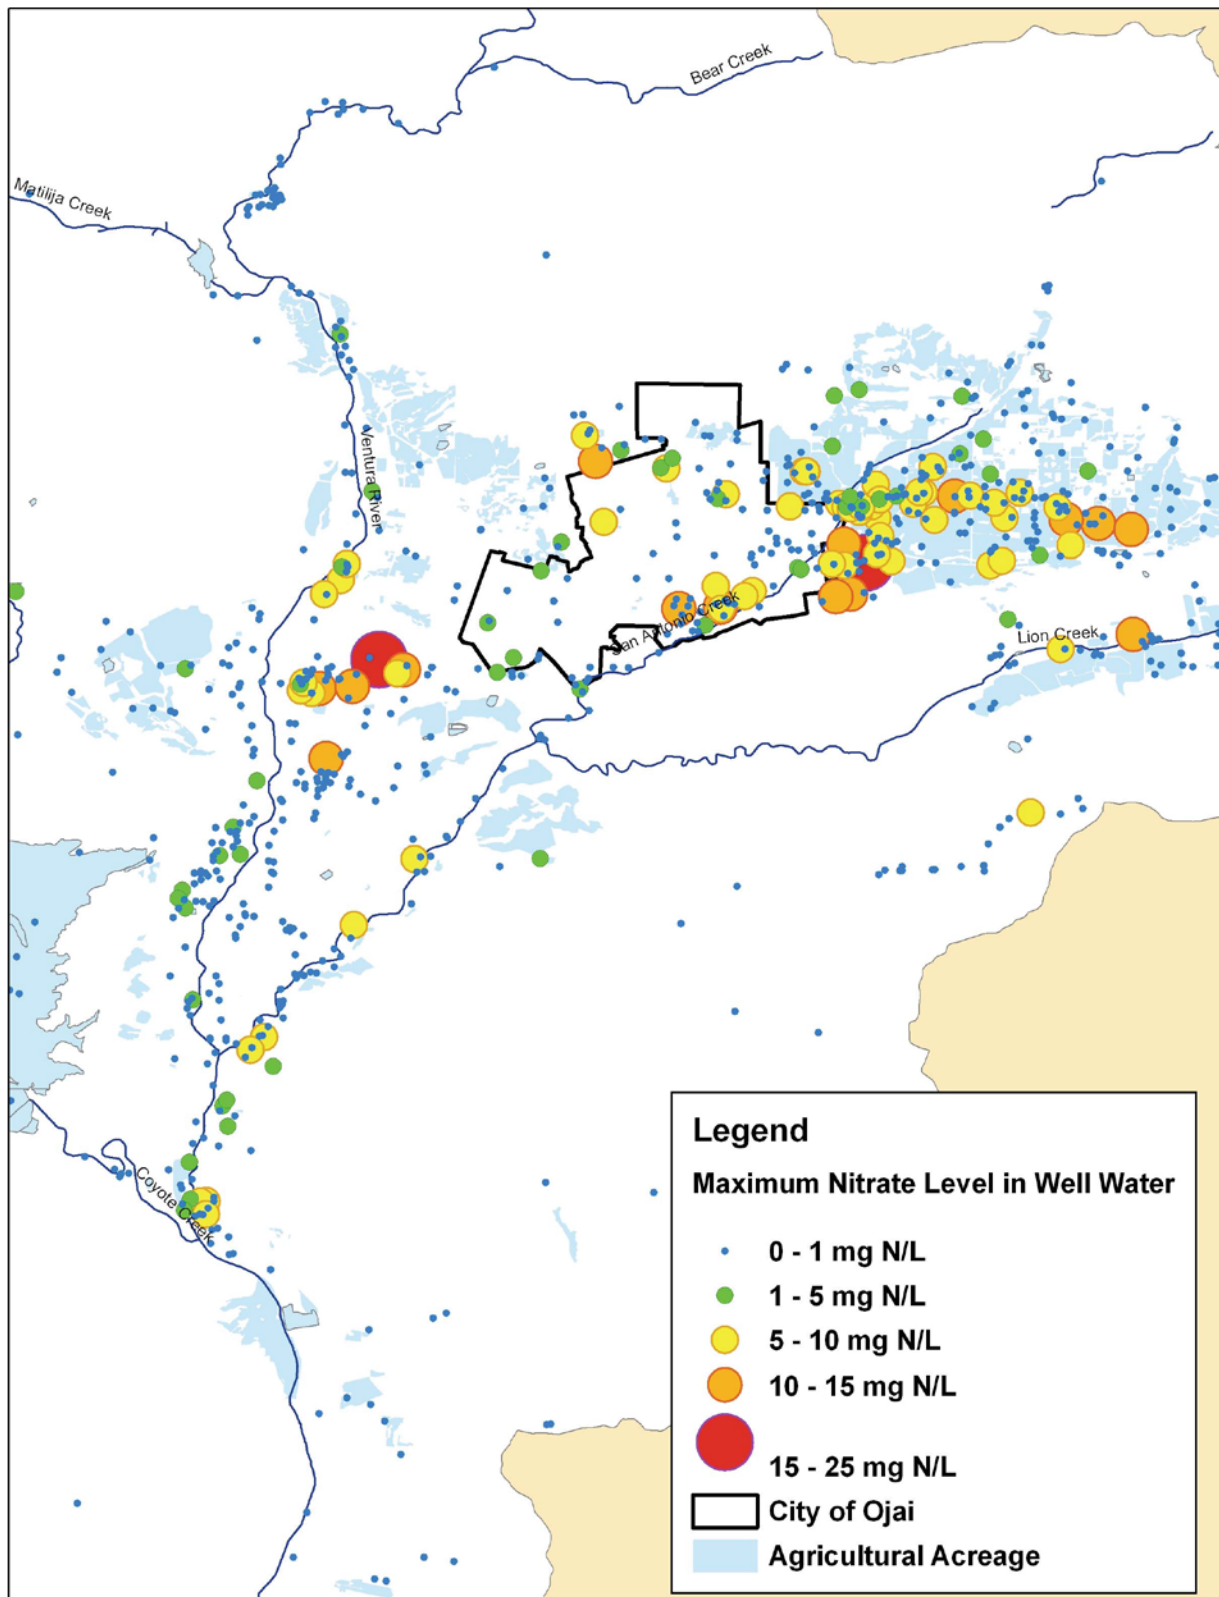
Figure 3.5.2.3.1 Maximum Nitrate Concentrations Observed in Wells, 1980–2008

Source: *Corrected Source Assessment Report: Nitrogen and Phosphorus in the Ventura River Watershed* (LWA 2011). The authors of this study used well water quality monitoring data from Ventura County Watershed Protection District. Range of sample dates varied among wells, but most samples are from the 1980s to 2008. Note: In this map nitrate is measured as nitrogen (N); in this form, the drinking water standard is 10 mg/L of nitrate as N (not 45 mg/L of nitrate as NO_3).

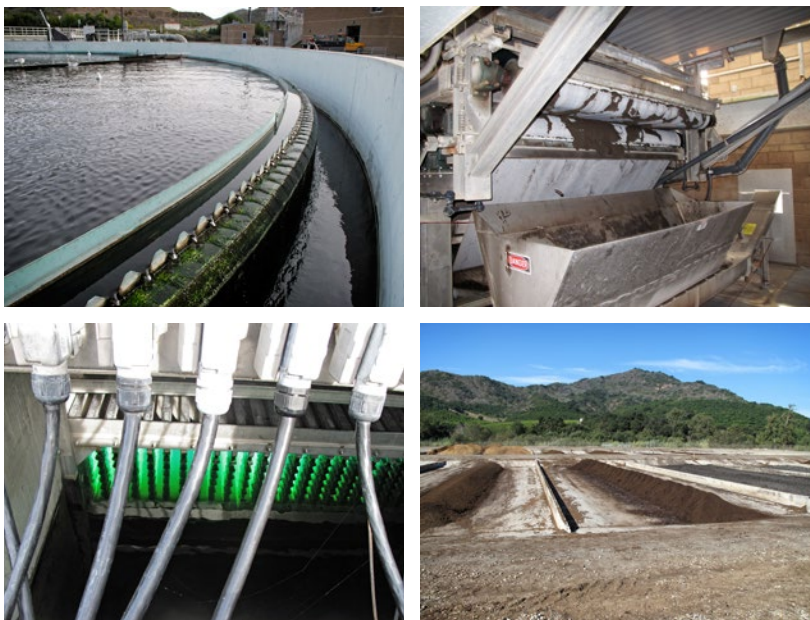
Treatment Processes. Clockwise from upper left: clarifier, biosolids, biosolids composting, ultraviolet light treatment. The Ojai Valley Sanitary District operates a state-of-the-art treatment system. The process includes biological treatment of the wastewater to remove harmful ammonia and other constituents. Wastewater is then filtered and treated with ultraviolet light to kill all the bacteria (Palmer 2013).

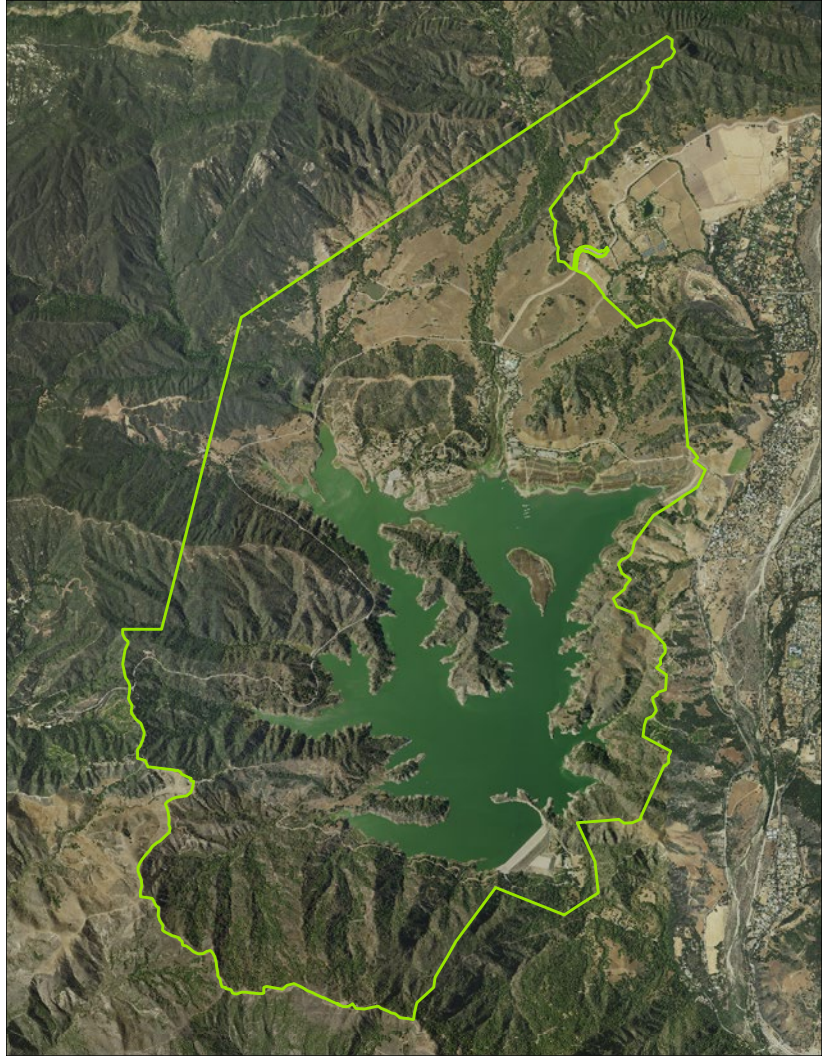
Figure 3.5.4.3.1 Lake Casitas Protected Lands Map. The Teague Memorial Watershed lands, together with the lands acquired by the Bureau of Reclamation as part of the original Ventura River Project (to create the dam, lake, and recreation area), total 9,401-acres. These lands provide a buffer of protected land around the lake.
